Reducing the Risks of Nonstructural Earthquake Damage – A Practical Guide

FEMA E-74 / December 2012

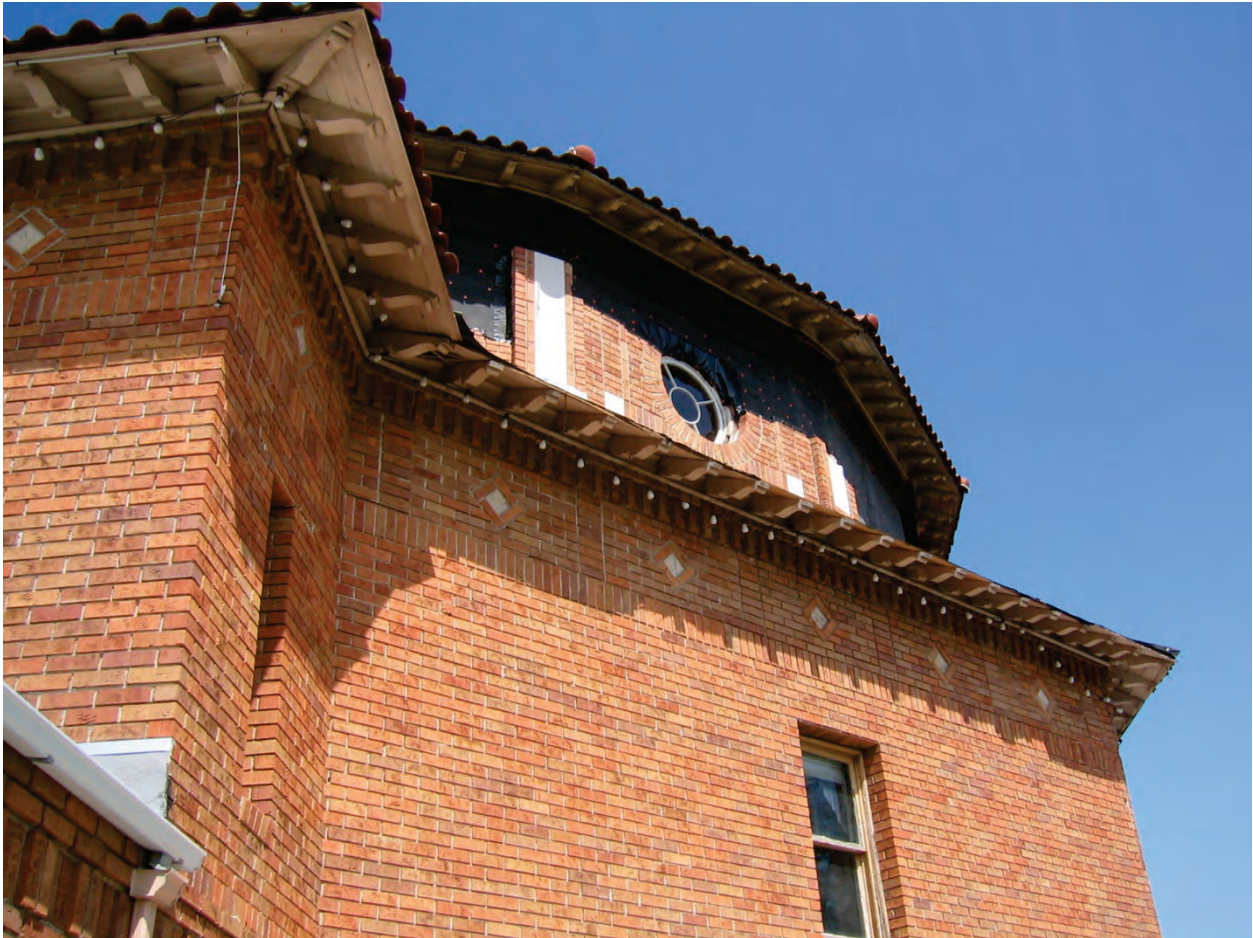
Figure 6.3.1.1-1 Failure of adhered masonry veneer at the Atascadero City Hall in the 2003 magnitude-6.5 San Simeon Earthquake (Photo courtesy of Mike Mahoney, FEMA).

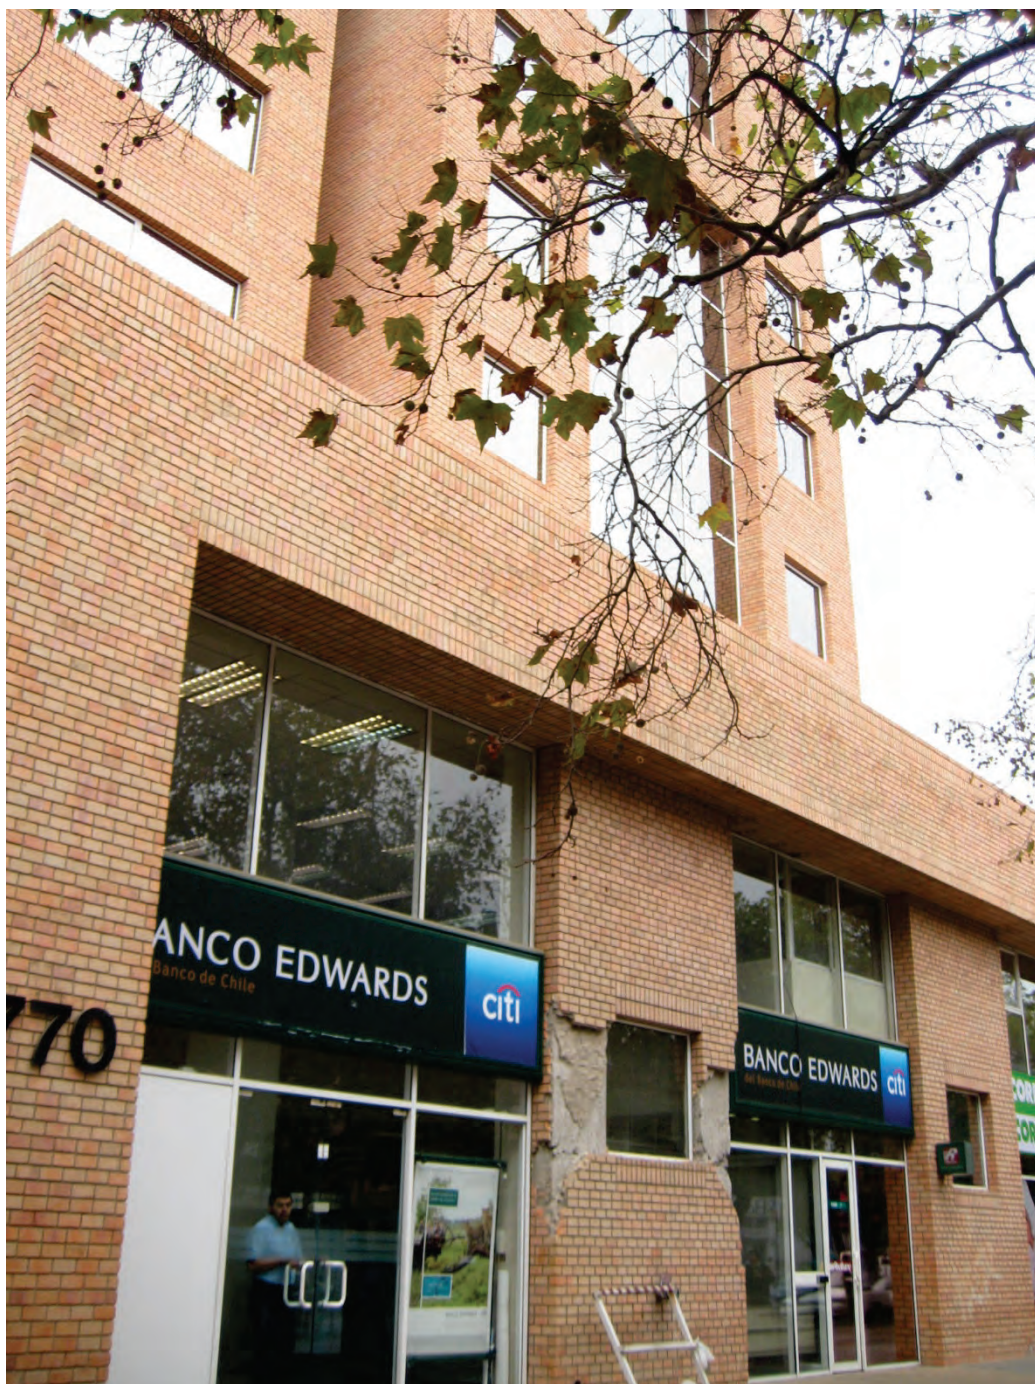
Figure 6.3.1.1-3 Cracked and spalled adhered veneer reveals incipient structural damage to concrete piers in Viña del Mar following the 2010 magnitude-8.8 Chile Earthquake. In this case, the areas of structural and nonstructural damage coincide; the adhered veneer remained intact over portions of the shear wall that did not deform significantly (Photo courtesy of Santiago Pujol, Purdue University).

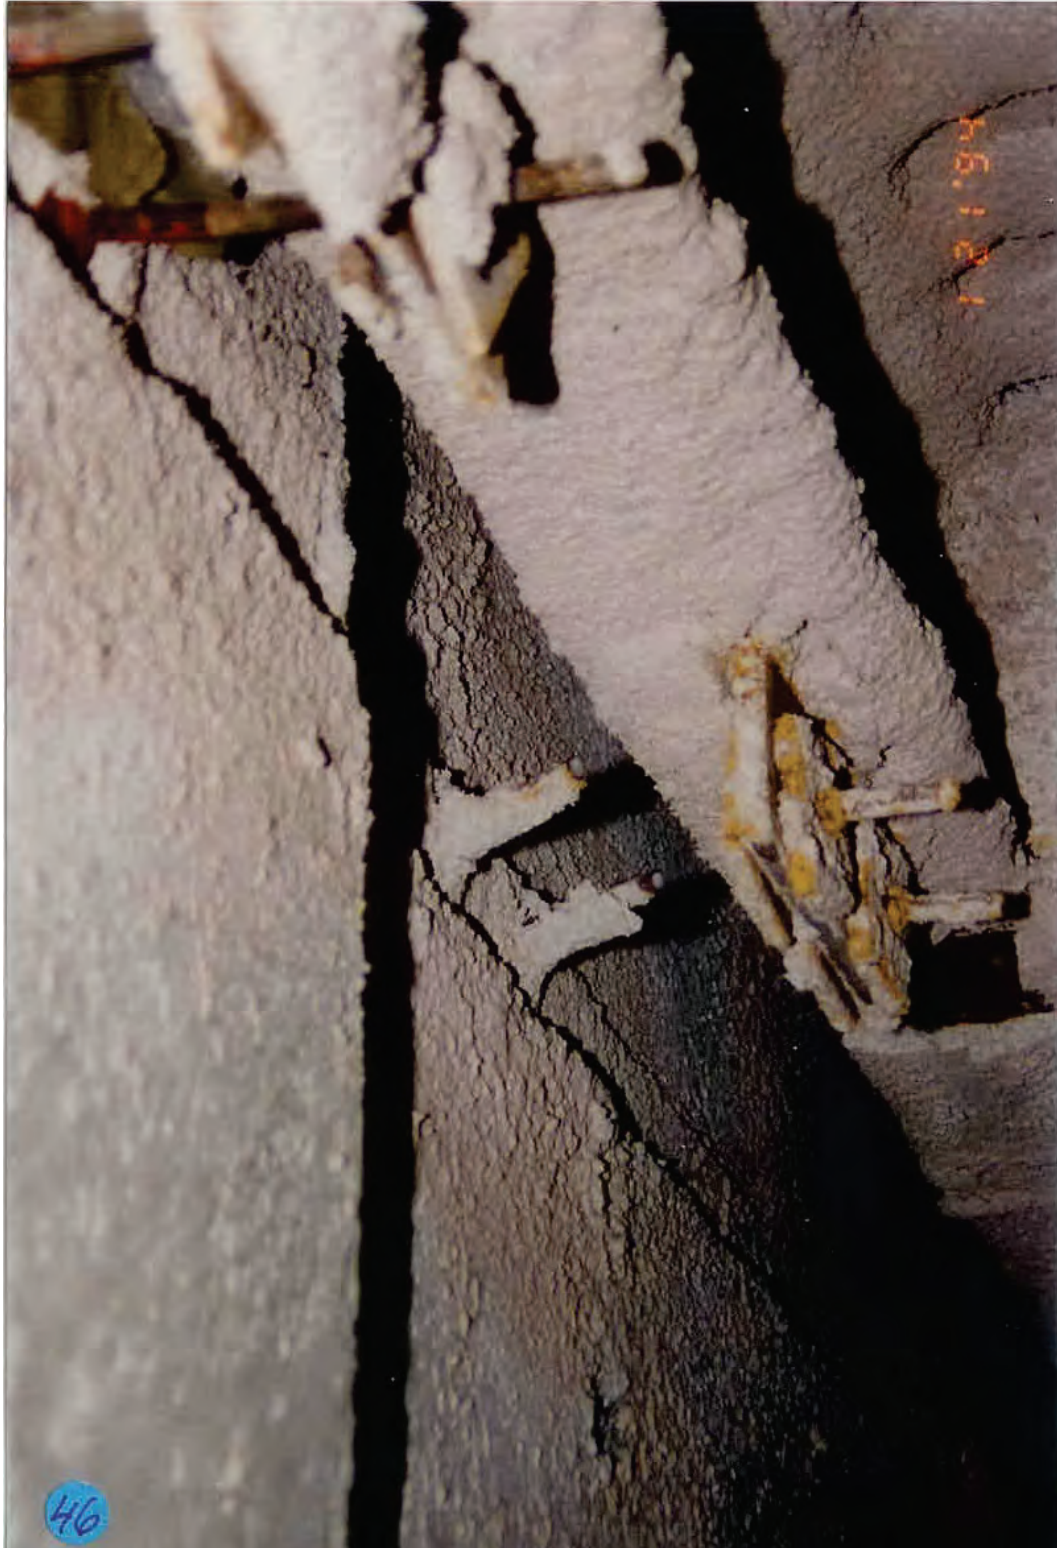
Figure 6.3.1.3-5 Close-up photo of two fractured connection bolts in a prefabricated panel in the 1994 Northridge Earthquake; corrosion of the rods may have contributed to the failure. (Photo courtesy of OSHPD).

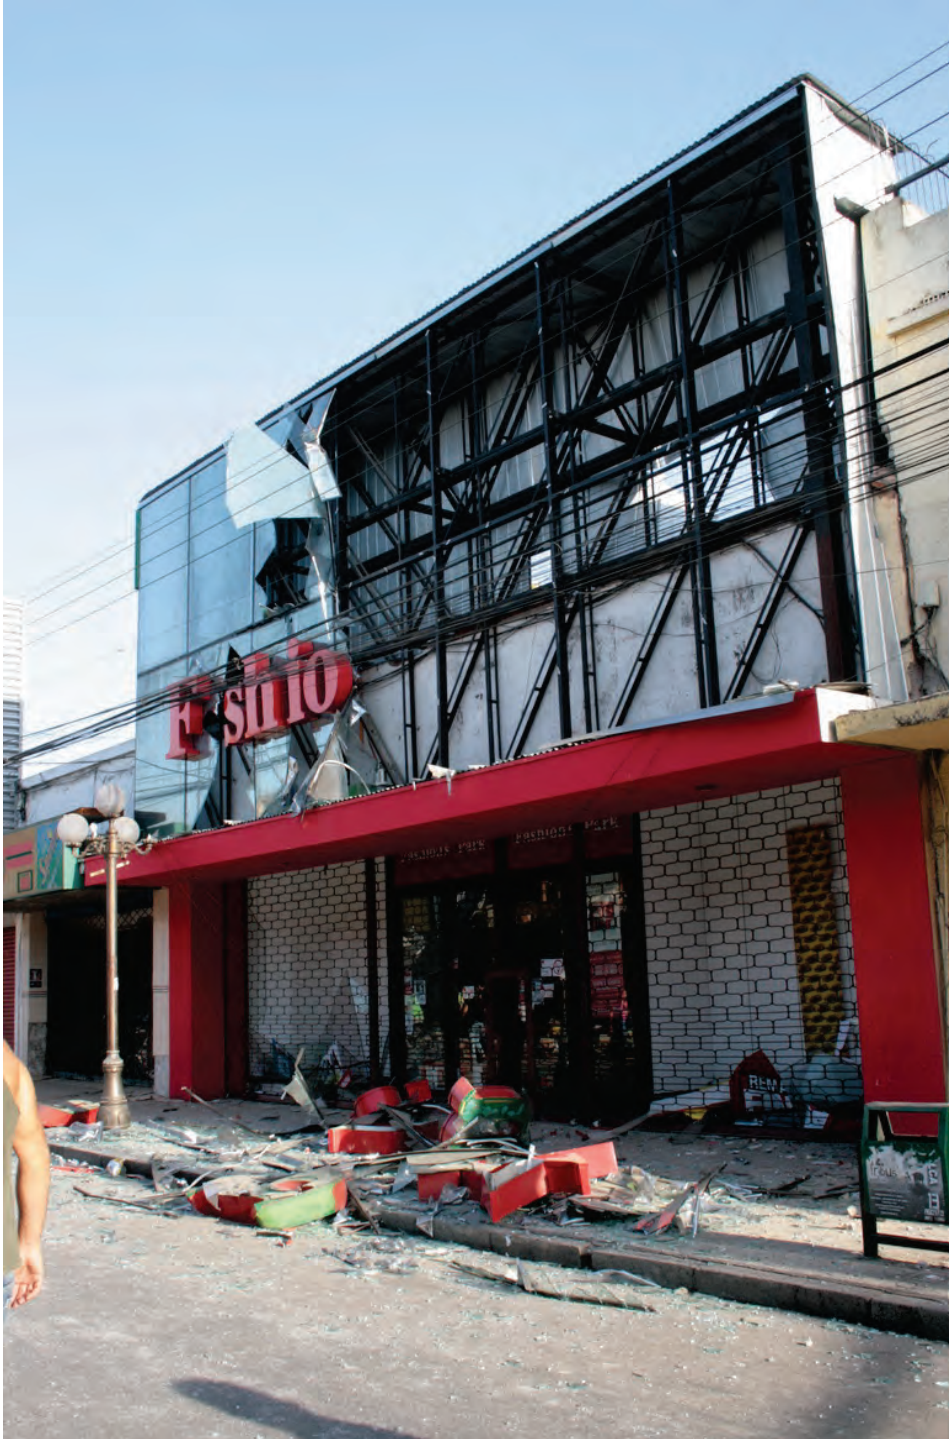
Figure 6.3.1.4-4 Glazing damage, due in part to pounding with the structure at right during the 2010 Chile Earthquake (Photo courtesy of Antonio Iruretagoyena, Rubén Boroscheck & Associates).

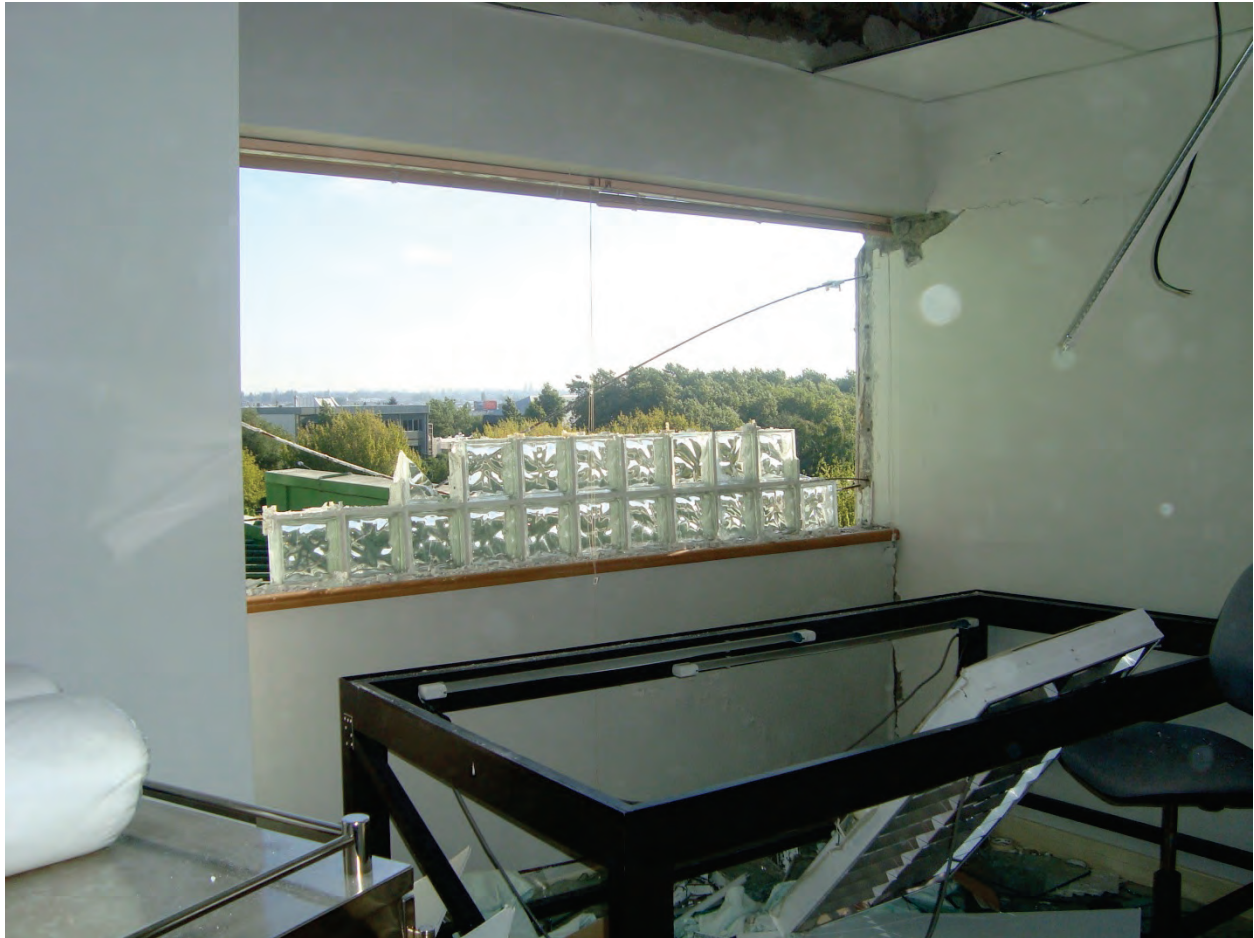
Figure 6.3.1.5-3 Damaged glass block panel from the Los Angeles Hospital in the 2010 Chile Earthquake; relatively new hospital building that had to be evacuated for repairs (Photo courtesy of Bill Holmes, Rutherford & Chekene). Blocks were installed with steel reinforcing bars in the top and bottom horizontal joints.

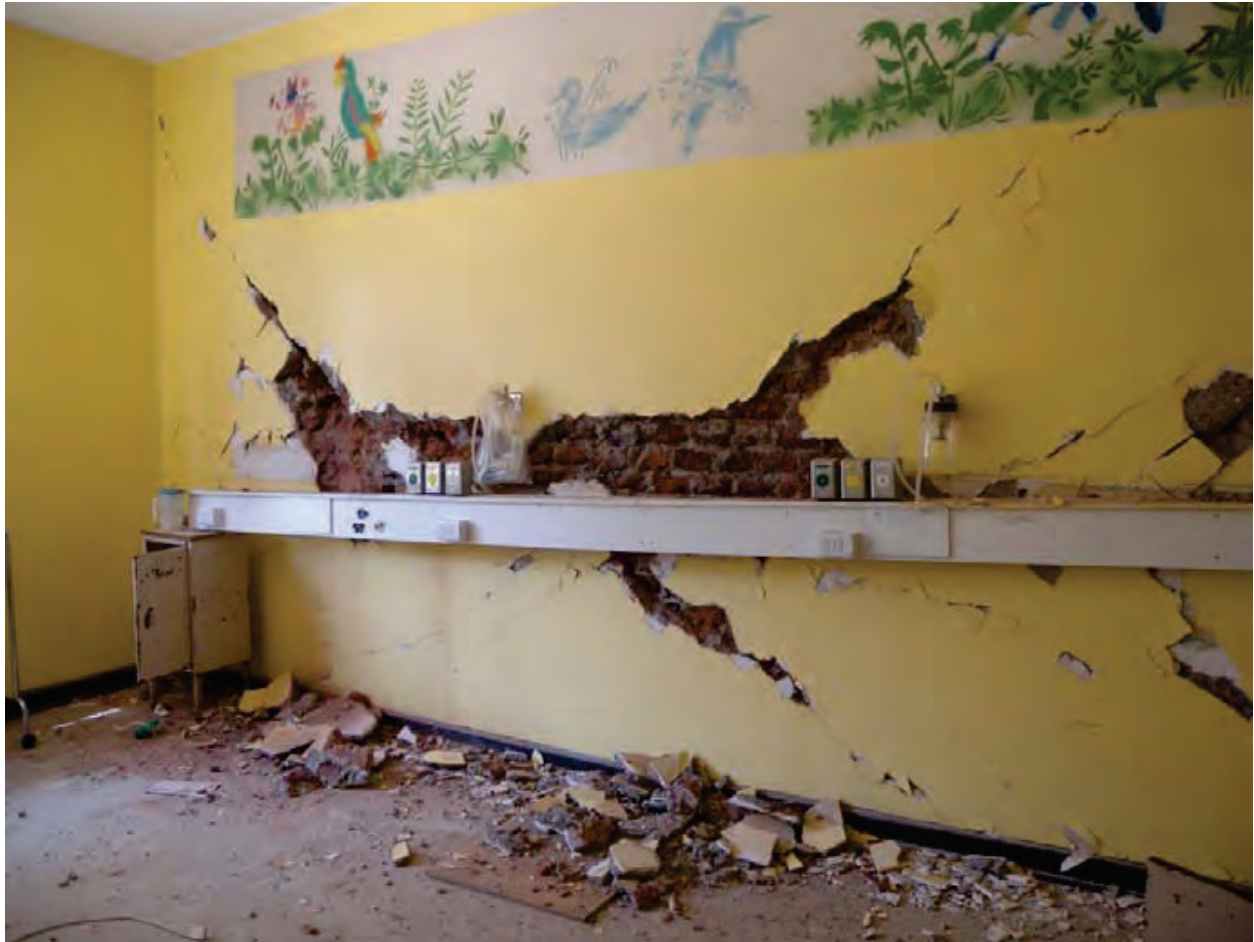
Figure 6.3.2.1-5 Damage to unreinforced brick partitions in patient rooms, and other mostly nonstructural damage, resulted in the evacuation of the Felix Bulnes Hospital in Santiago in the 2010 magnitude-8.8 Chile Earthquake (Photo courtesy of Gilberto Mosqueda, University of Buffalo, SUNY).

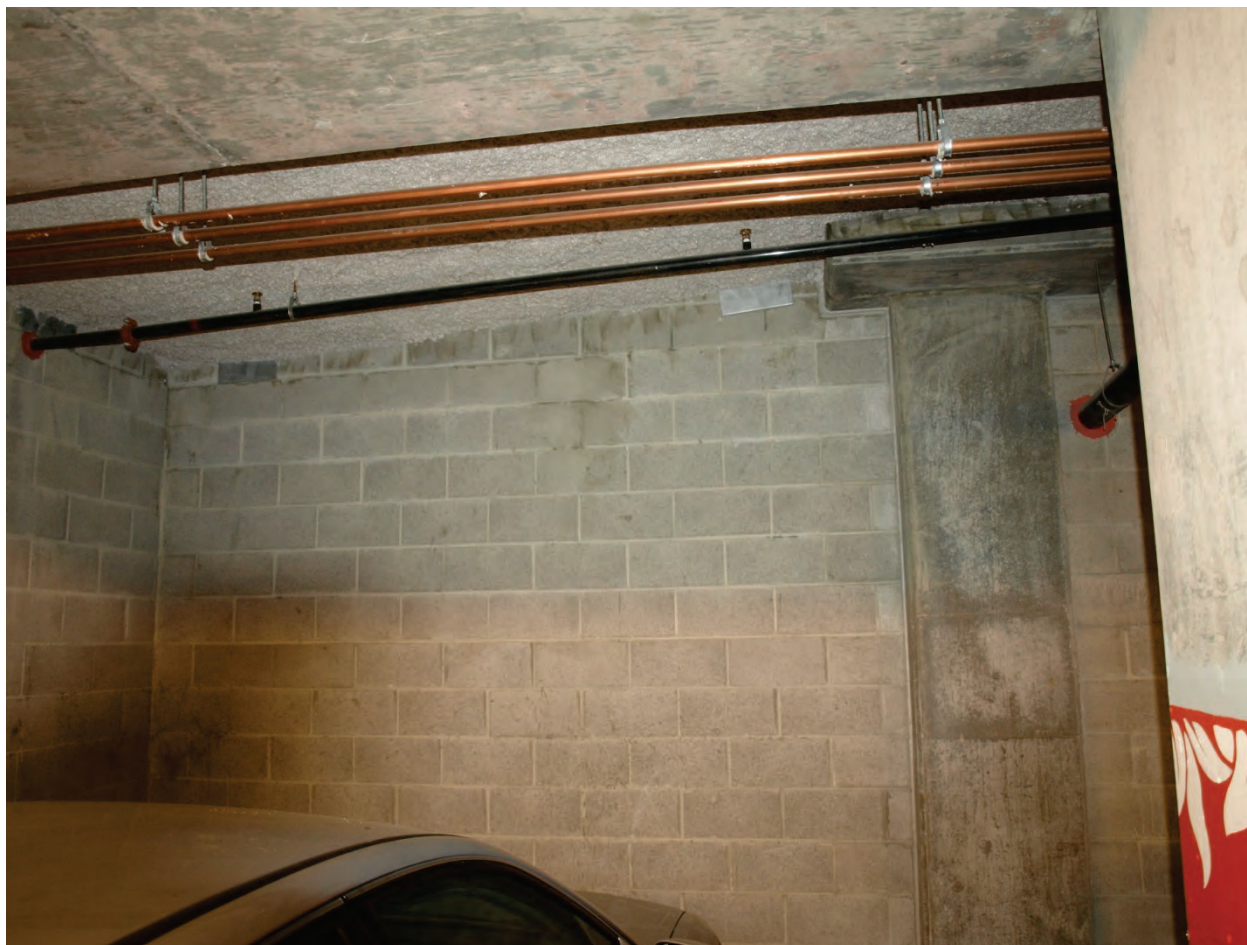
Figure 6.3.2.1-8 Full-height concrete masonry unit walls detailed with steel clip angles (3 angles visible in photo). Configuration shown includes perpendicular walls, sloping ramp above, and column with column capital. Although wall detailed with sealant joints along edges of column and column capital, it is not clear that the concrete frame can move independently of these CMU walls (Photo courtesy of Cynthia Perry, BFP Engineers).

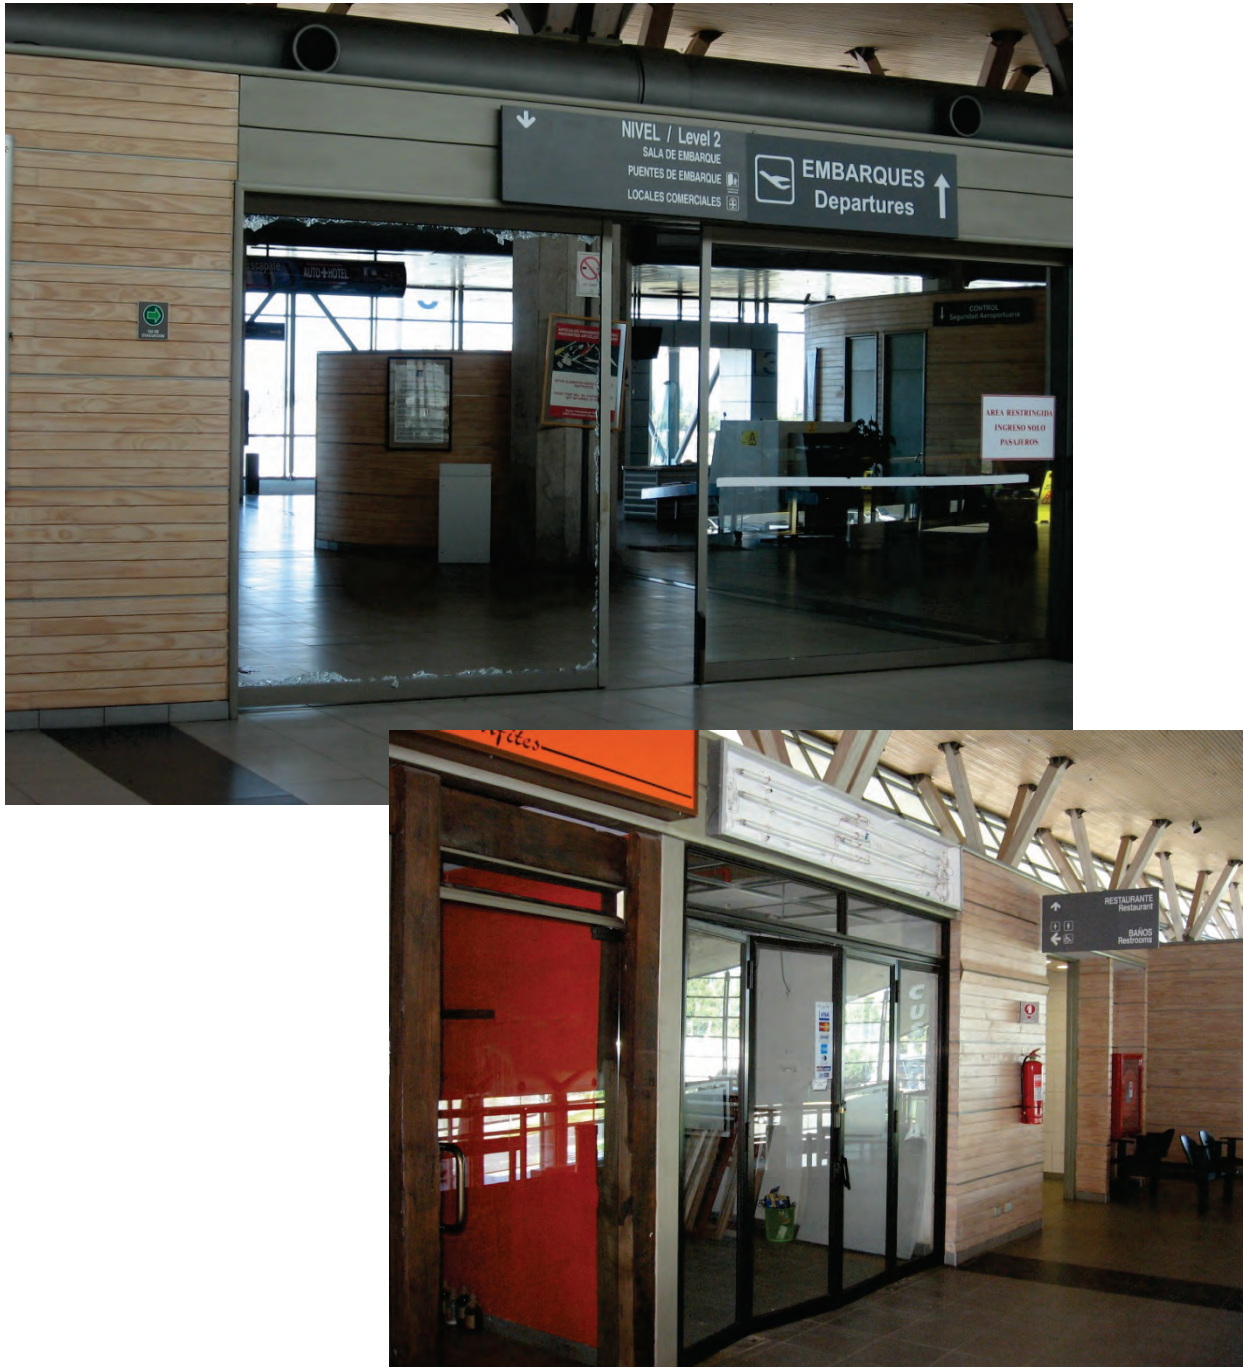
Figure 6.3.2.3-2 Damage to glazed doors at the Concepción airport in the 2010 Chile Earthquake. In the top photo the glazing in the sliding glass door shattered; in the lower photo the glass is intact but the door frames are misaligned (Photos courtesy of Rodrigo Retamales, Rubén Boroschek & Associates).

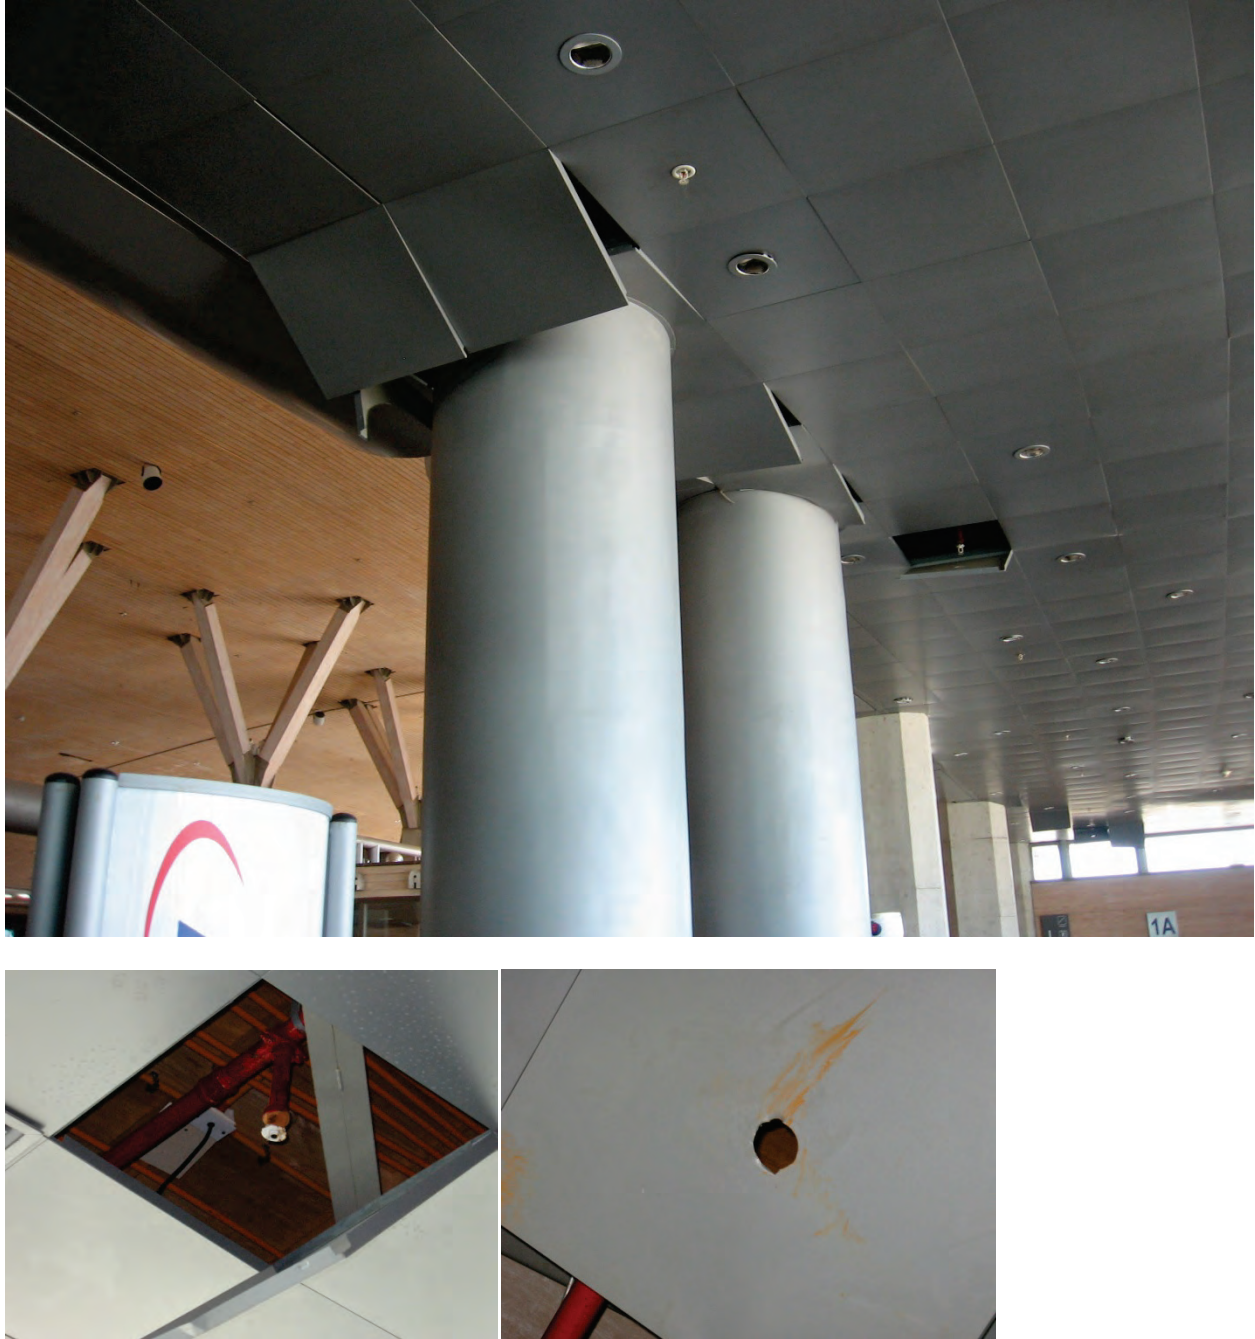
Figure 6.3.4.1-5 Damage to suspended metal panel ceiling system and fire sprinklers at Concepción airport, primarily at far end and around column obstructions in the 2010 Chile Earthquake (Photos courtesy of Rodrigo Retamales, Rubén Boroschek & Associates). The metal panel was strong enough to fail the sprinkler head shown at lower left.

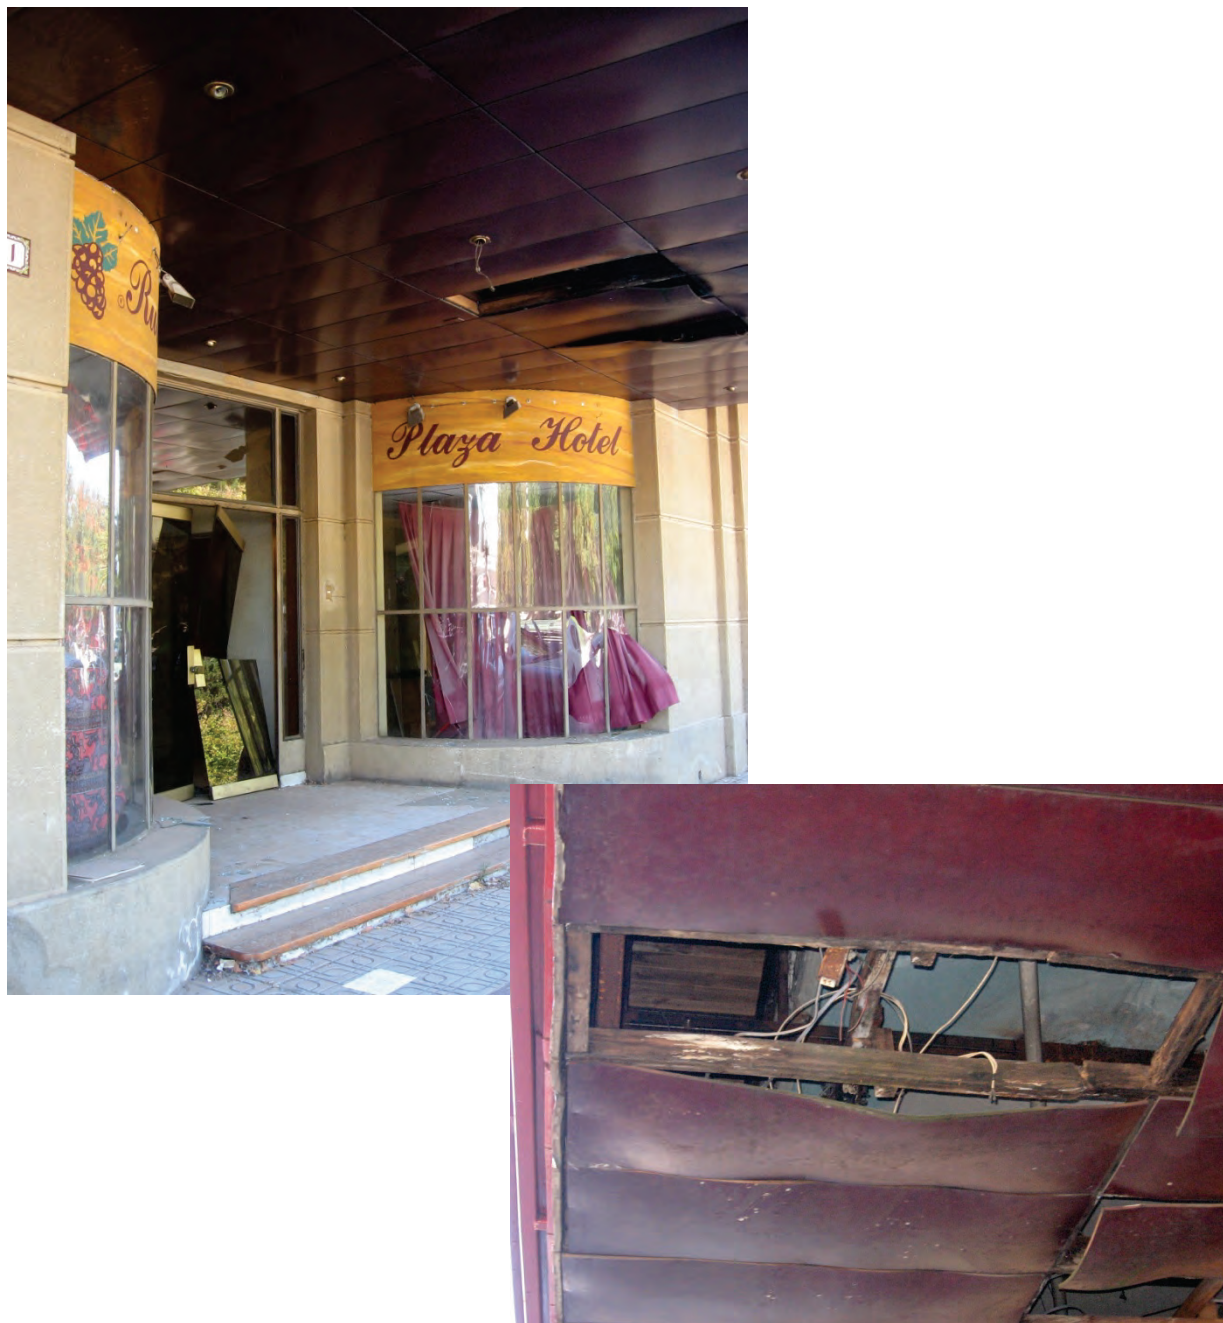
Figure 6.3.4.2-3 Damage to soffit paneling and wood framing at hotel in the 2010 Chile Earthquake; panels and wood framing show signs of prior water damage and deterioration. Note also damage to storefront glazing and glass doors (Photos courtesy of Rodrigo Retamales, Rubén Boroscchek & Associates).

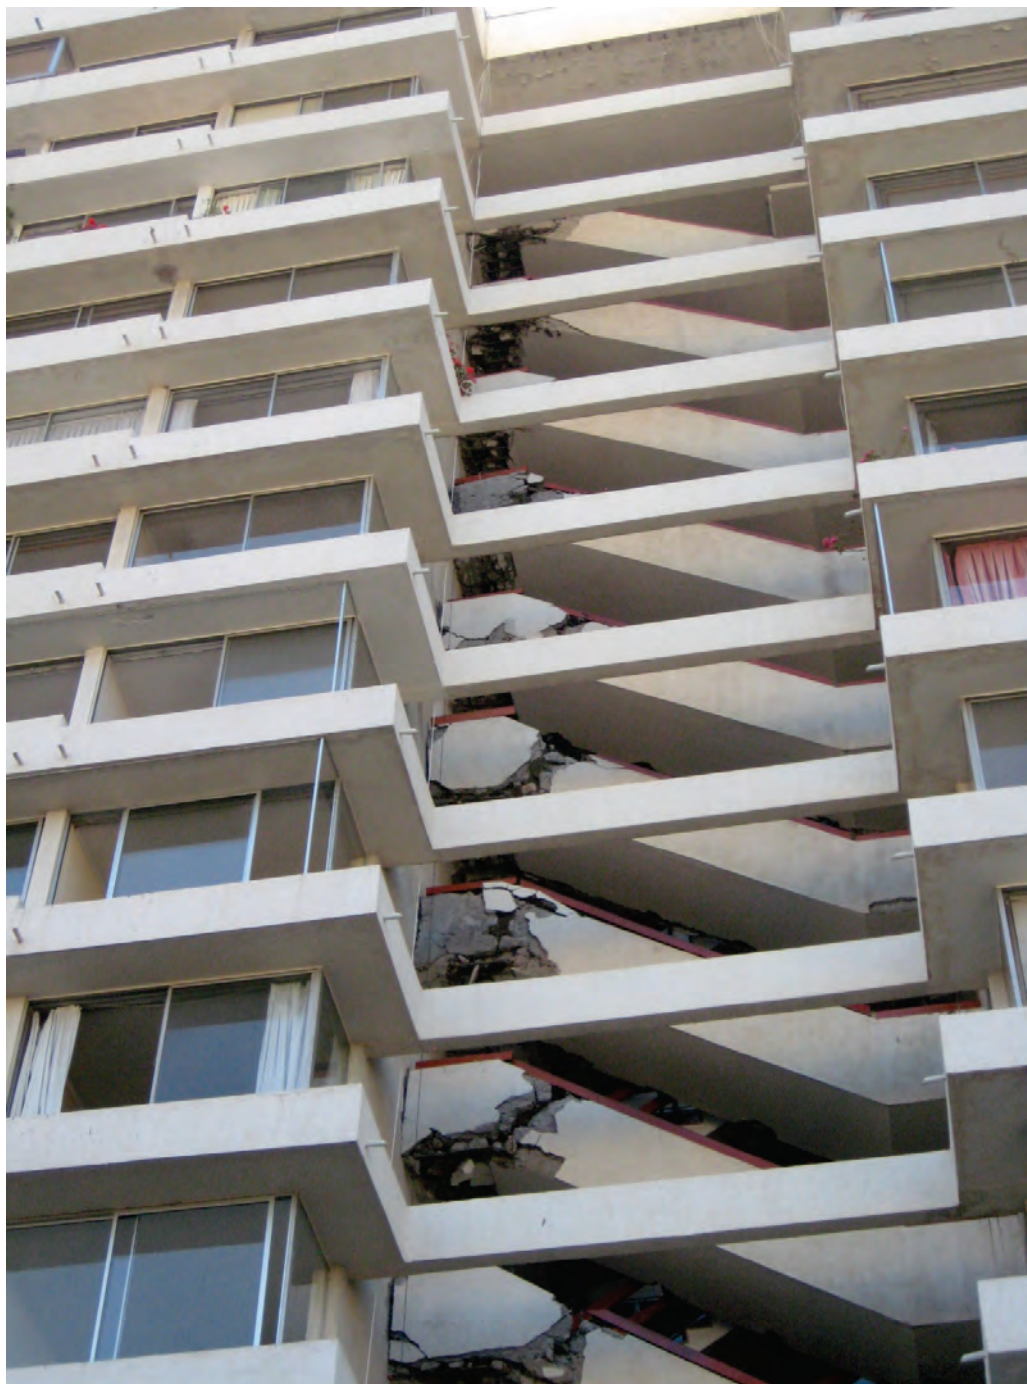
Figure 6.3.8.1-3 Stairs damaged up the full height of this apartment building in Viña del Mar in the 2010 magnitude-8.8 Chile Earthquake (Photo courtesy of Santiago Pujol, Purdue University). The stairs were rigidly attached at adjacent floors and behaved like diagonal braces although they were neither designed nor detailed to function as structural braces.

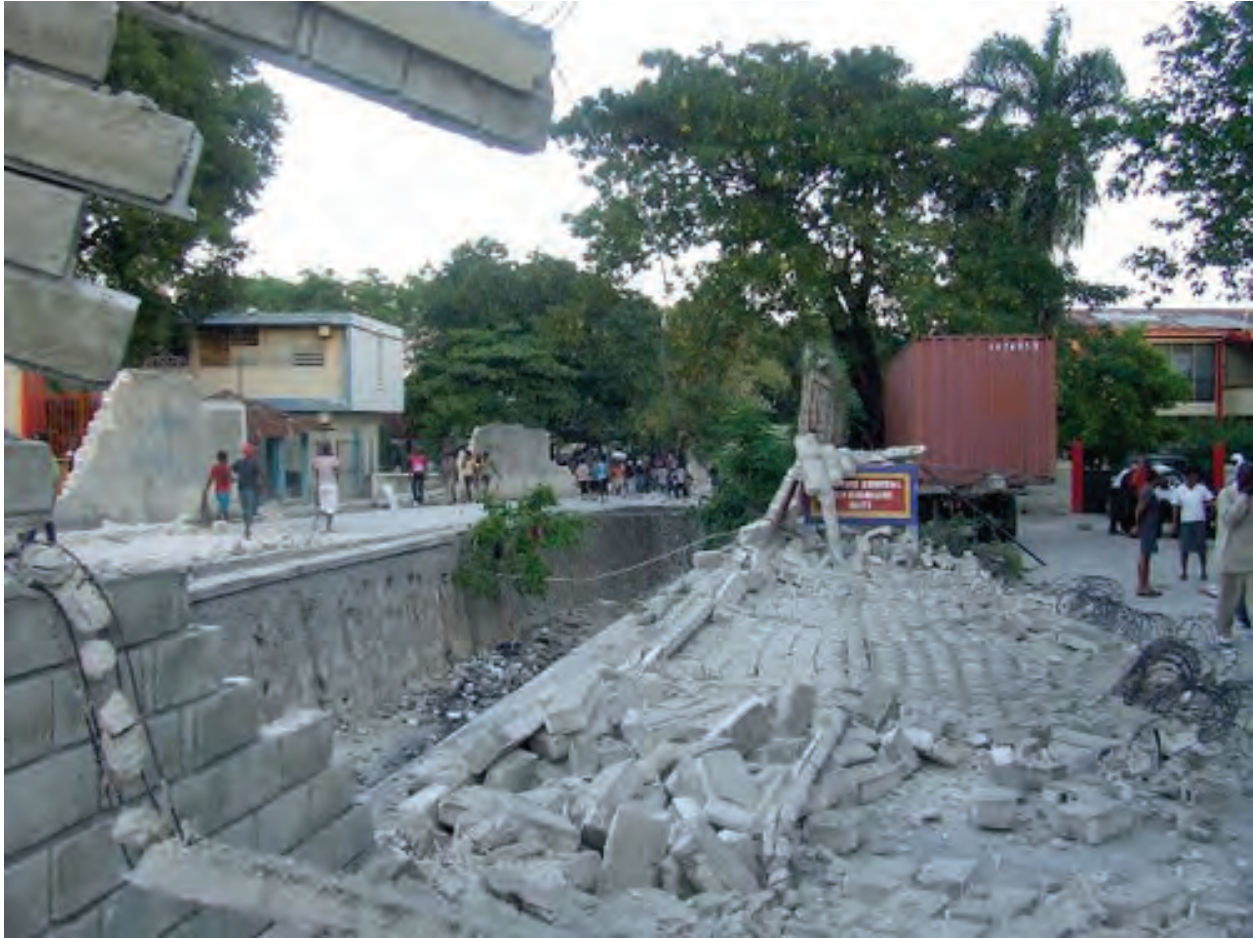
Figure 6.3.9.1-2 Freestanding masonry fences with inadequate reinforcement collapsed covering both sides of this street in Port-au-Prince in the 2010 magnitude-7 Haiti Earthquake (Photo courtesy of Yves Montoban). Many miles of such fencing collapsed in the 2010 Haiti Earthquake.

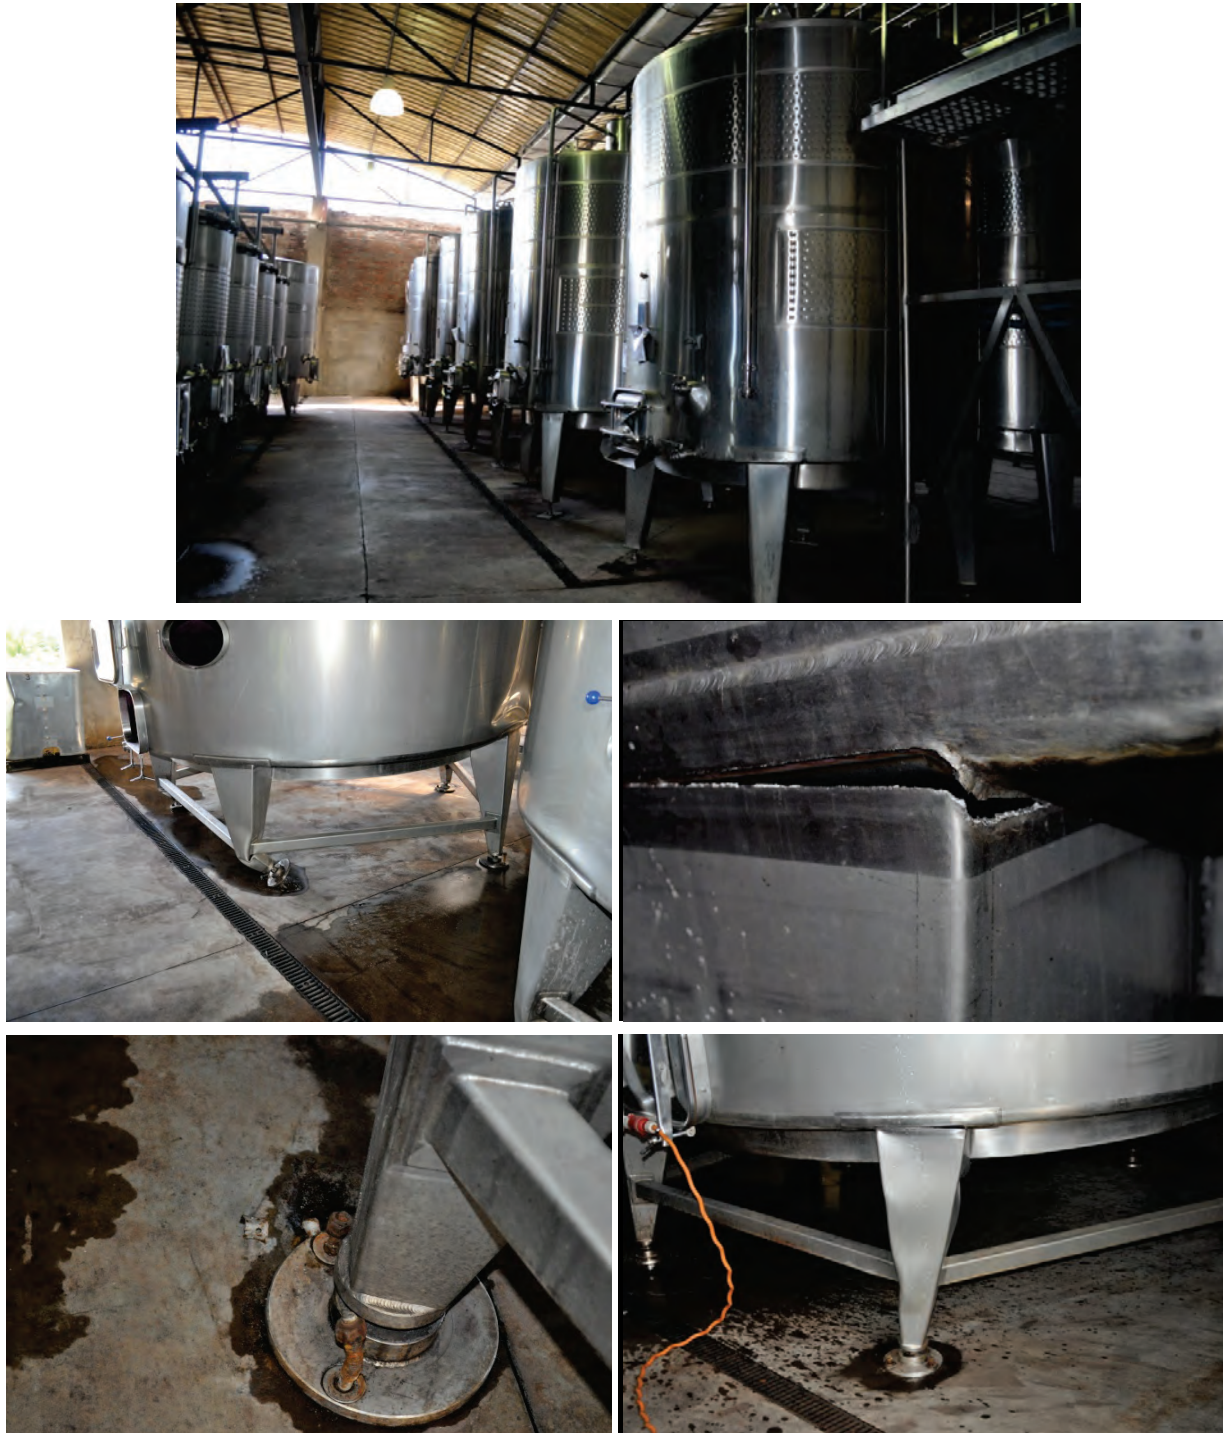
Figure 6.4.2.1-4 Wineries suffered extensive damage in the 2010 magnitude-8.8 Chile Earthquake with many barrels of wine spilled. This winery had damage to anchored tanks; tank anchorage failed, legs buckled, welds tore, anchor bolts pulled up, etc. The tank legs all have leveling bolts at the bottom, creating a weak zone between the bottom of the leg and the anchor plate. Similar unanchored tanks in this facility shifted position but were undamaged (Photos courtesy of Eduardo Fierro, BFP Engineers).

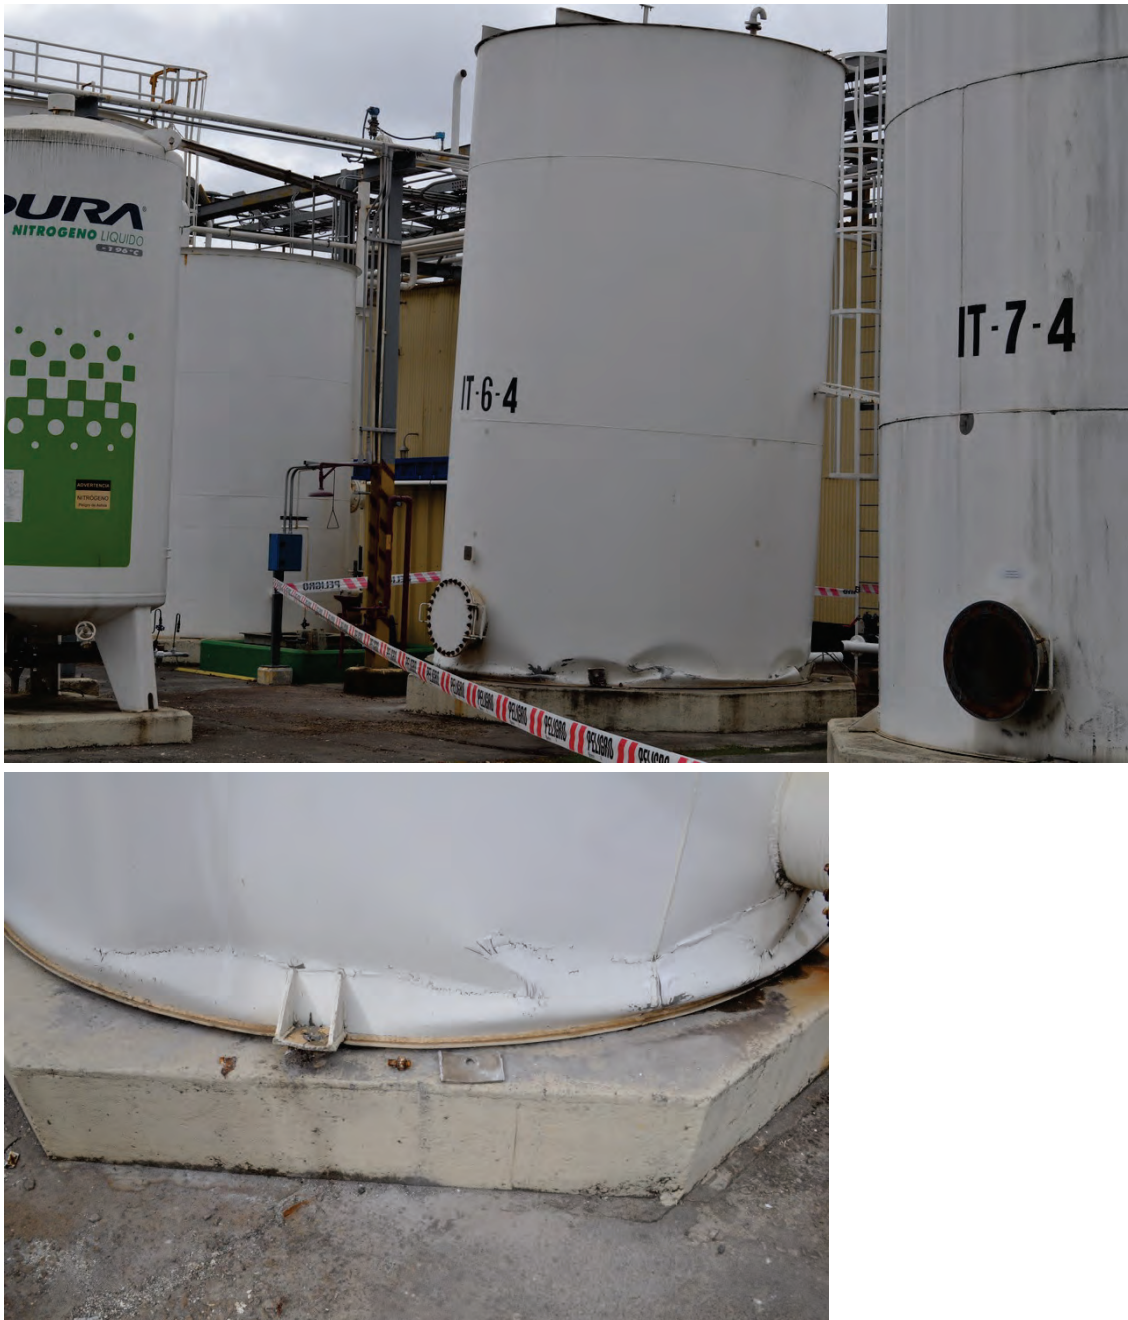
Figure 6.4.2.2-4 Anchored tank damaged at base when anchorage failed; tank slid and ruptured attached piping in 2010 magnitude-8.8 Chile Earthquake (Photo courtesy of Eduardo Fierro, BFP Engineers).

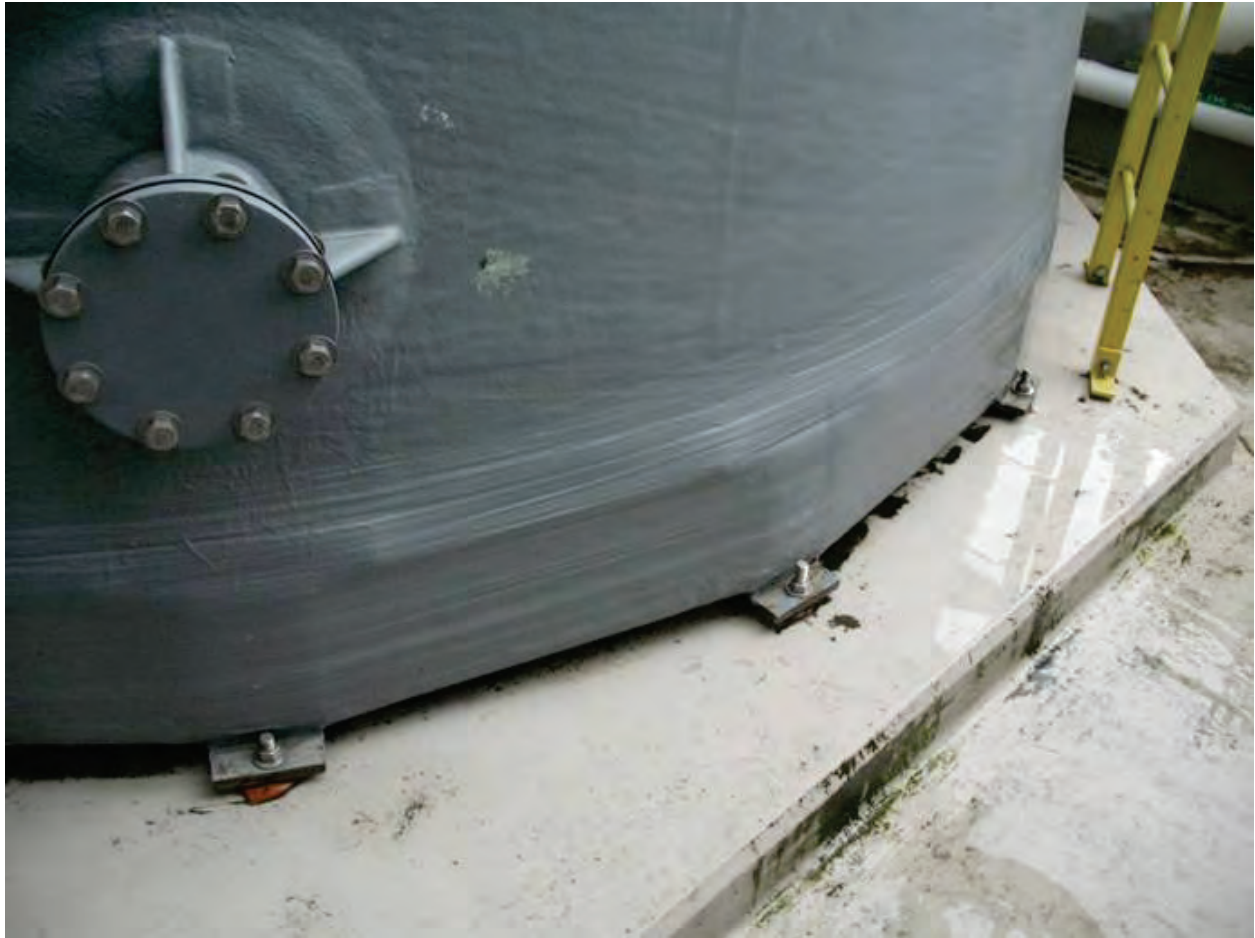
Figure 6.4.2.2-6 Anchors at base of fiberglass reinforced plastic tank (Photo courtesy of Jeffrey Soulages, Intel).
