Reducing the Risks of Nonstructural Earthquake Damage – A Practical Guide

FEMA E-74 / December 2012

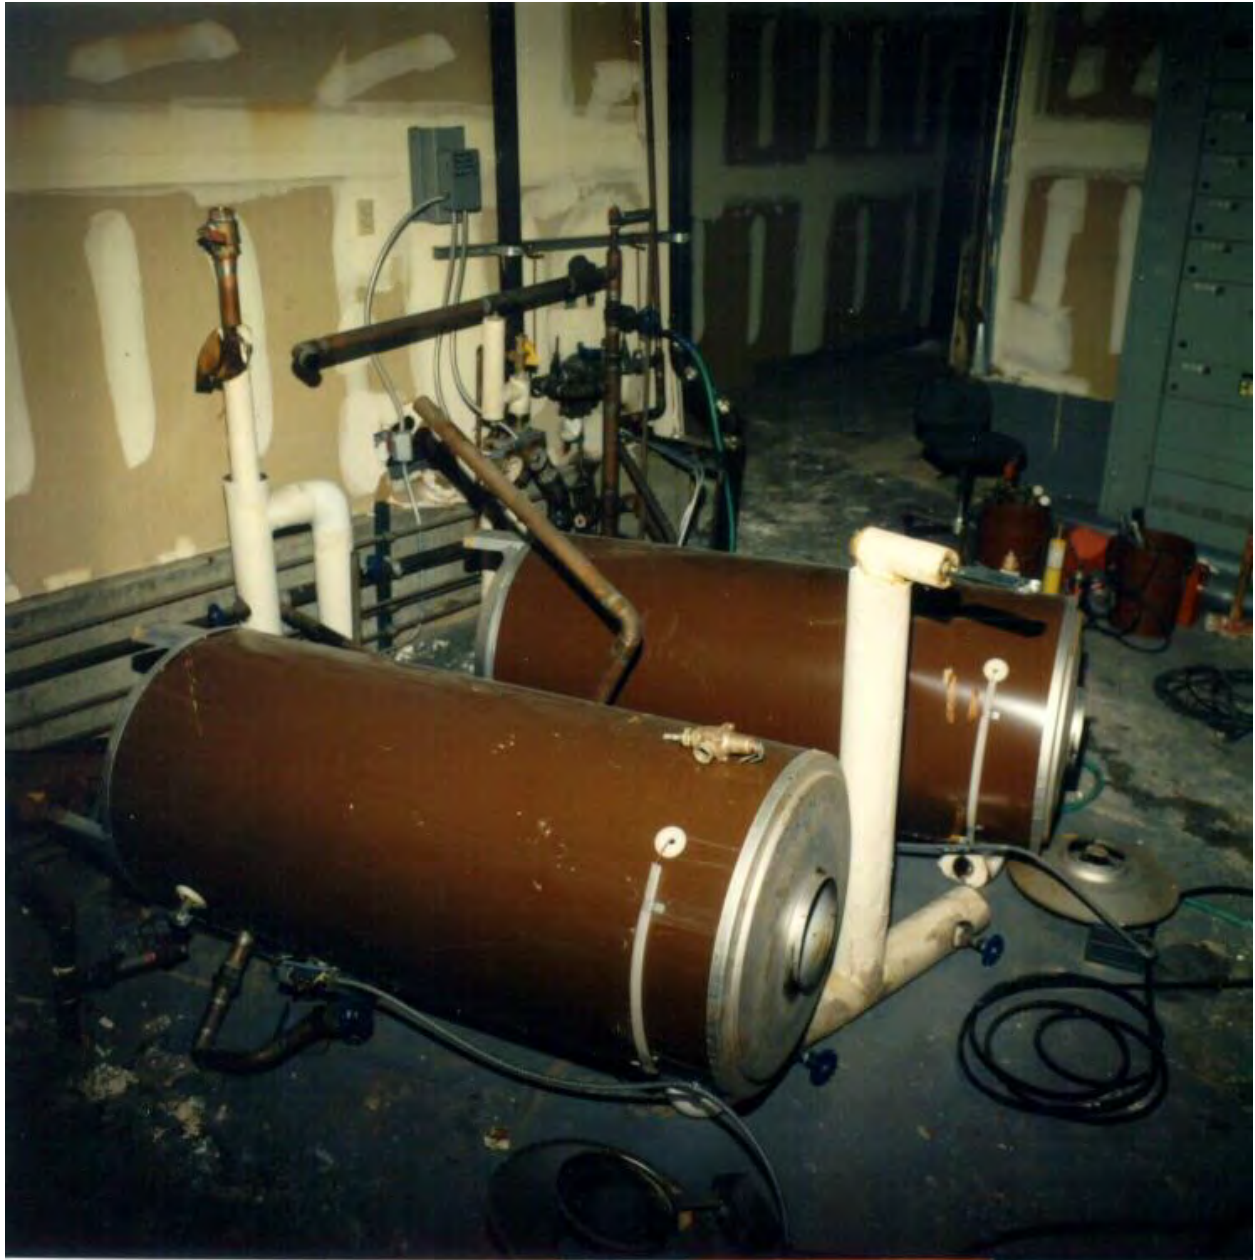
Figure 6.4.2.4-1 Unanchored water heaters overturned (Photo courtesy of Mason Industries).

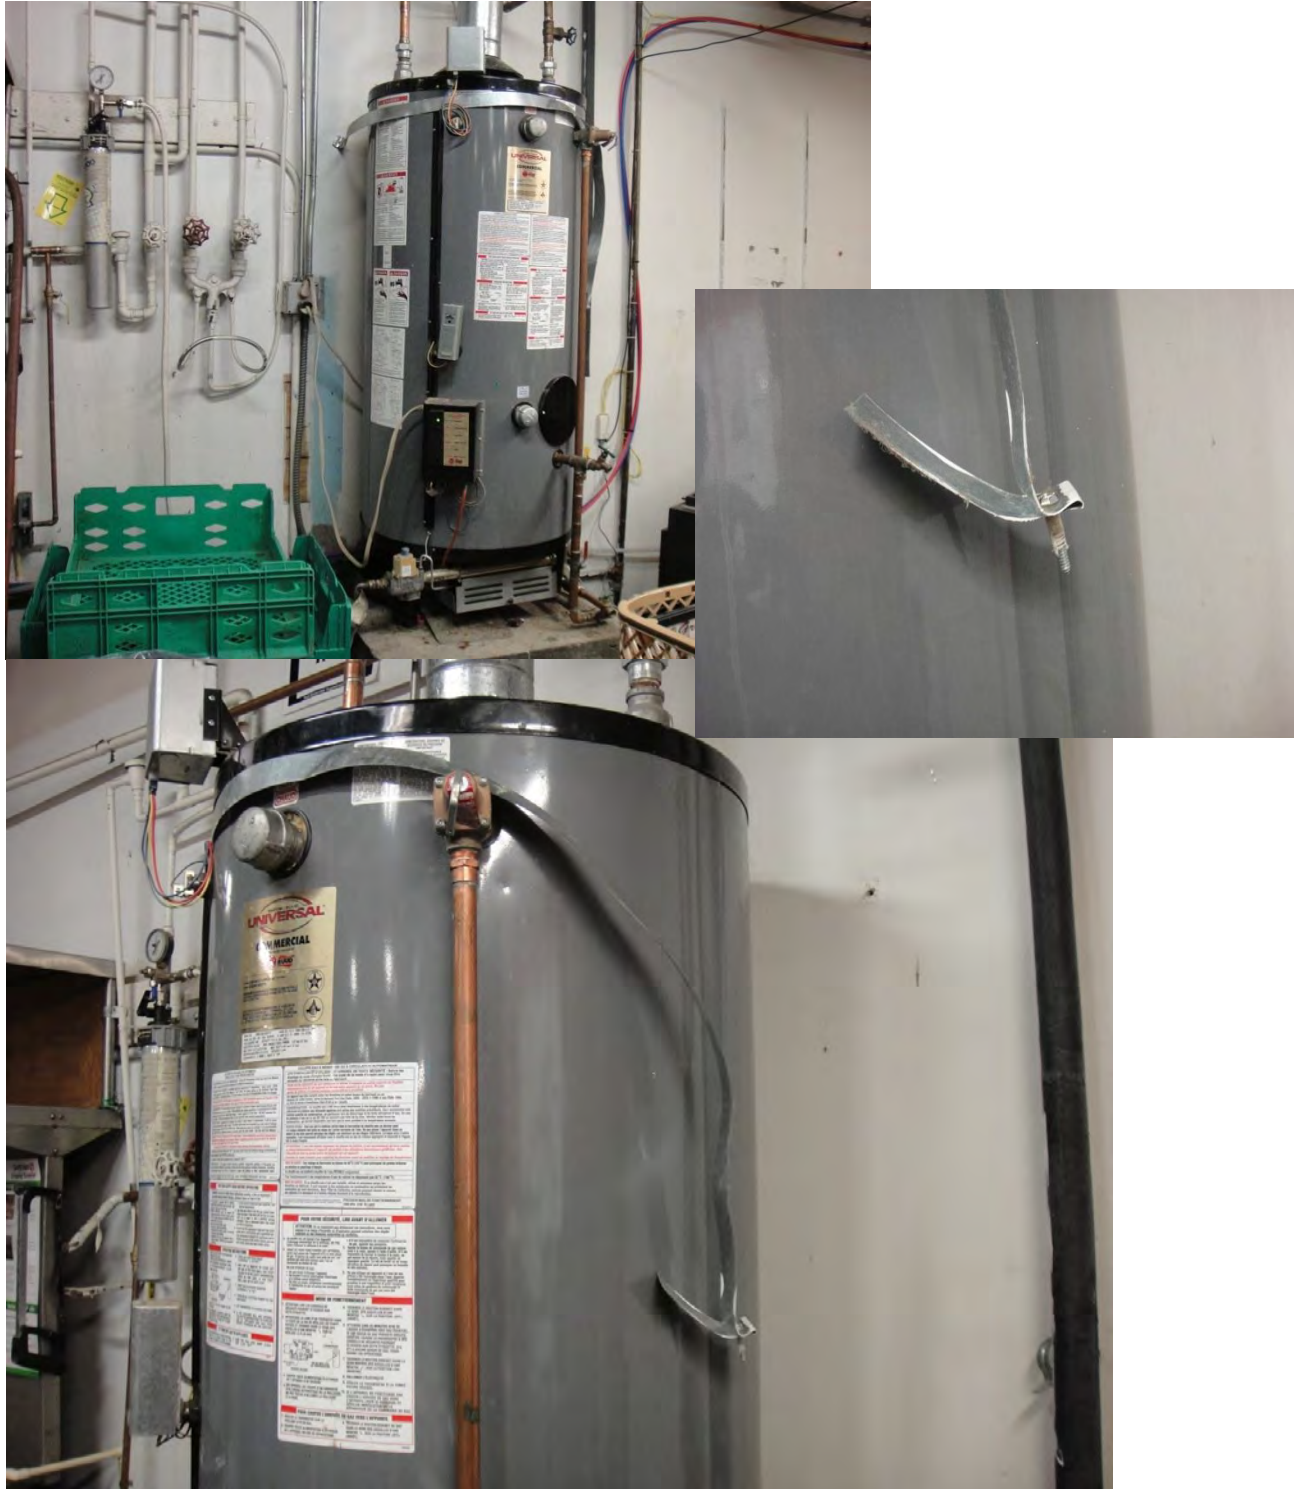
Figure 6.4.2.4-3 Damaged water heater in the 2010 magnitude-6.5 Eureka Earthquake. The water heater strap pulled out from the supporting concrete wall as a result of inadequate anchorage. The tank moved sufficiently to break interconnected water lines which were rigidly connected to the tank.

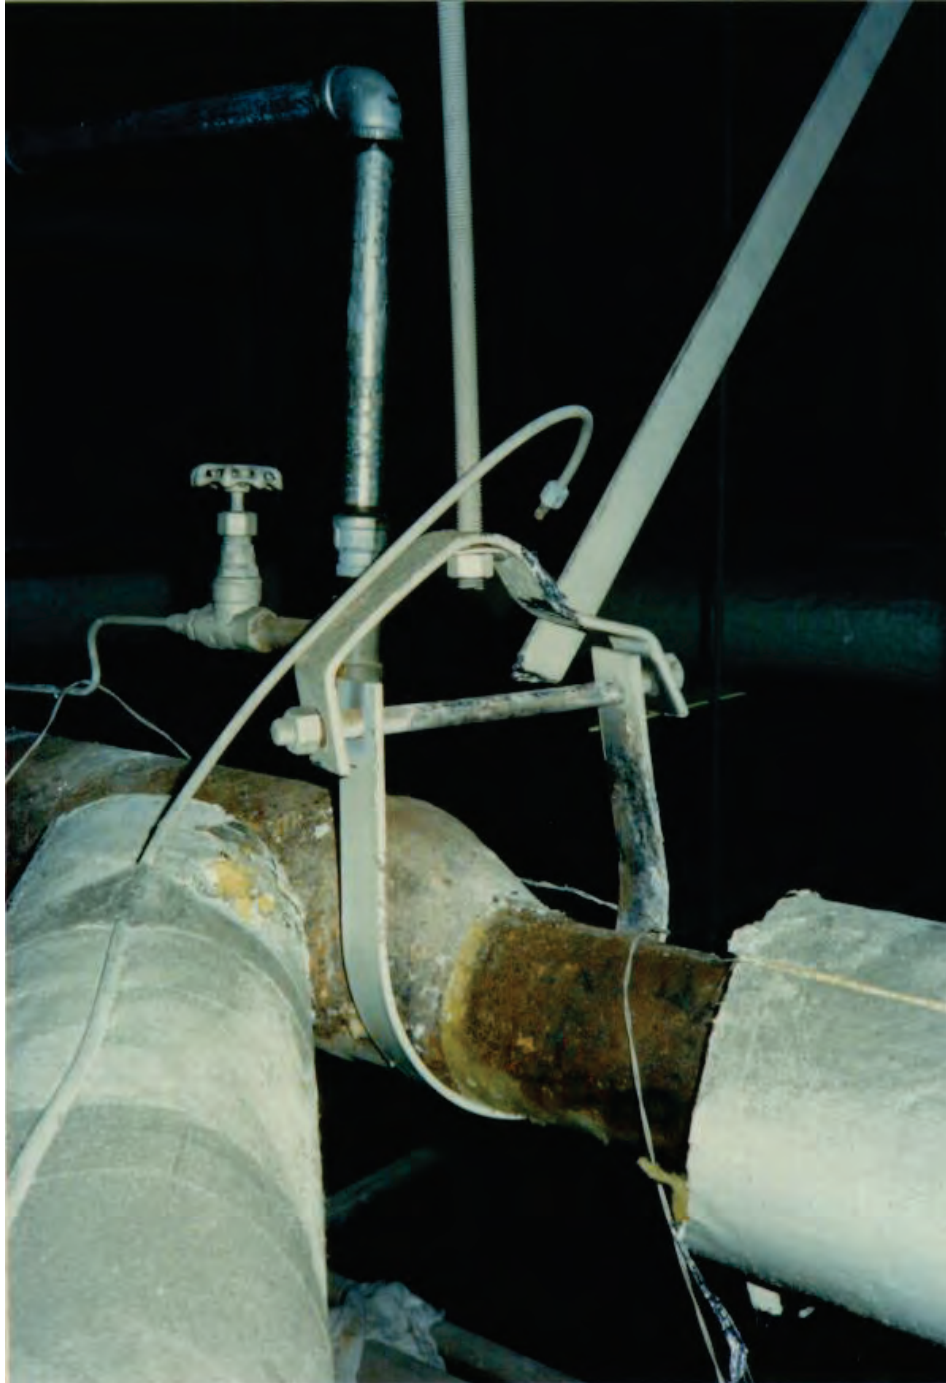
Figure 6.4.3.1-3 Pipe brace failed at connection in 1994 Northridge Earthquake; insulation removed prior to photo (Photo courtesy of Mason Industries).

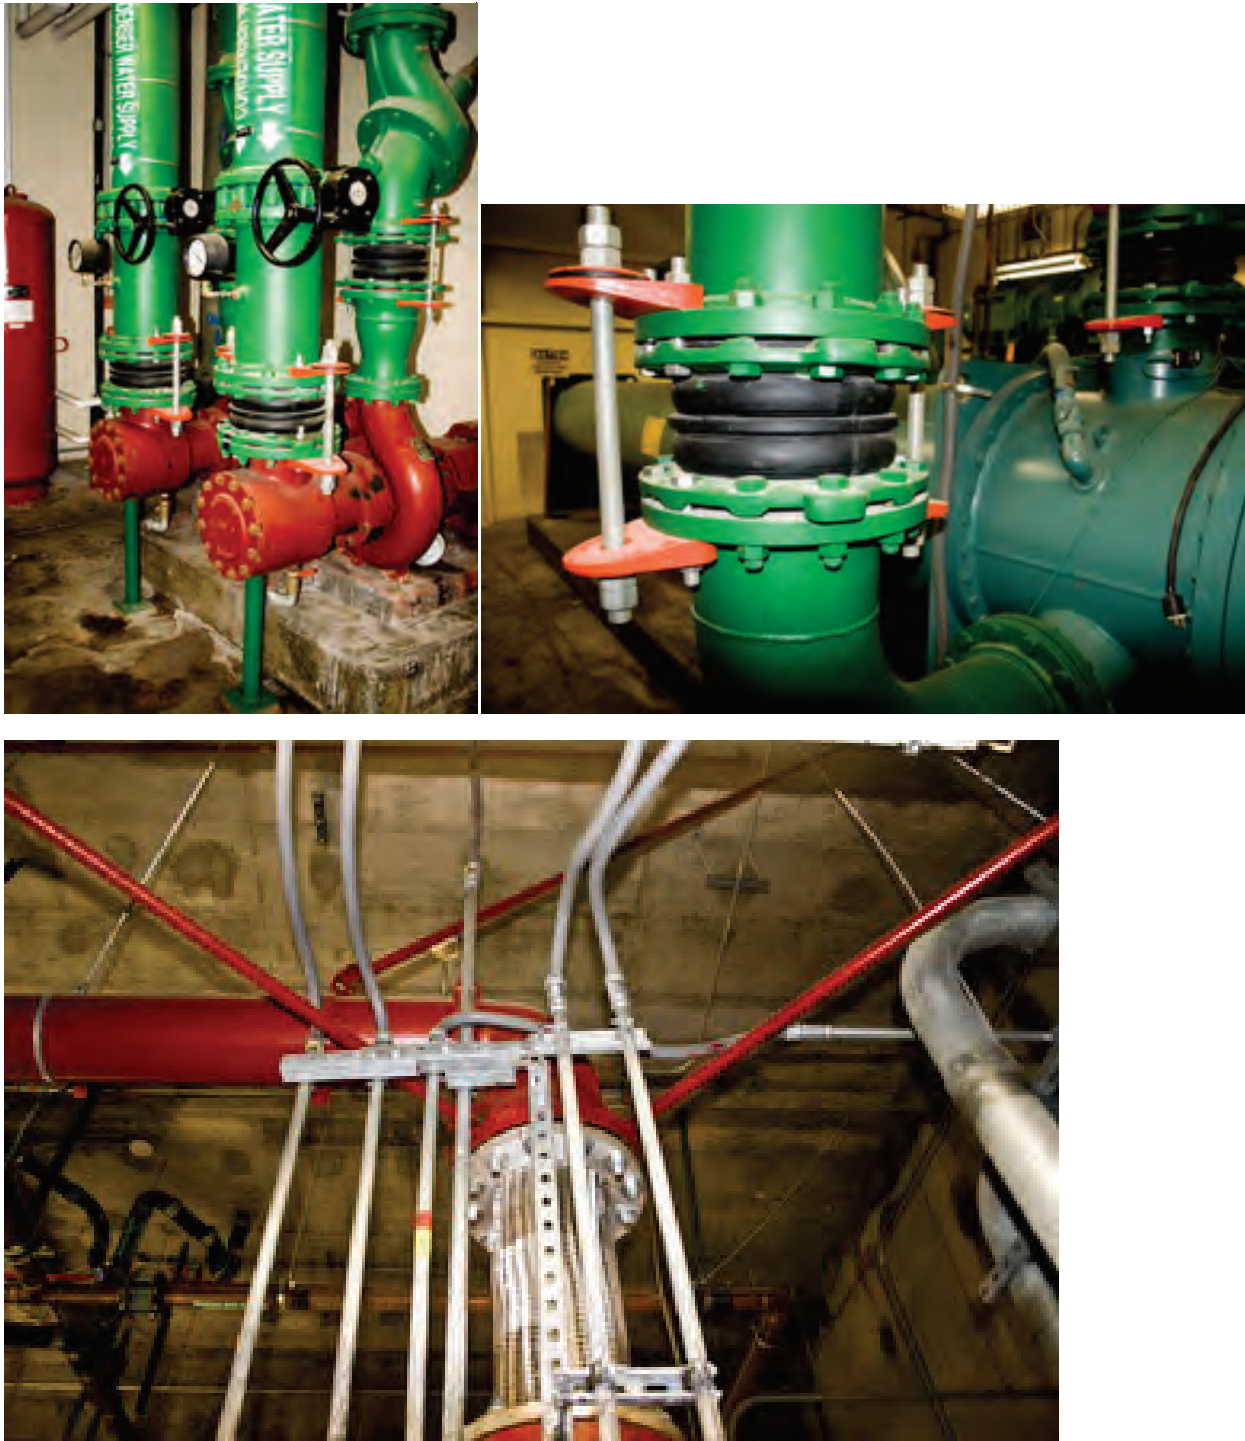
Figure 6.4.3.3-2 Examples of flexible couplings that performed well in the 2010 magnitude-7 Haiti Earthquake; the building suffered relatively minor damage (Photo courtesy of Tom Sawyer, Engineering News Record).

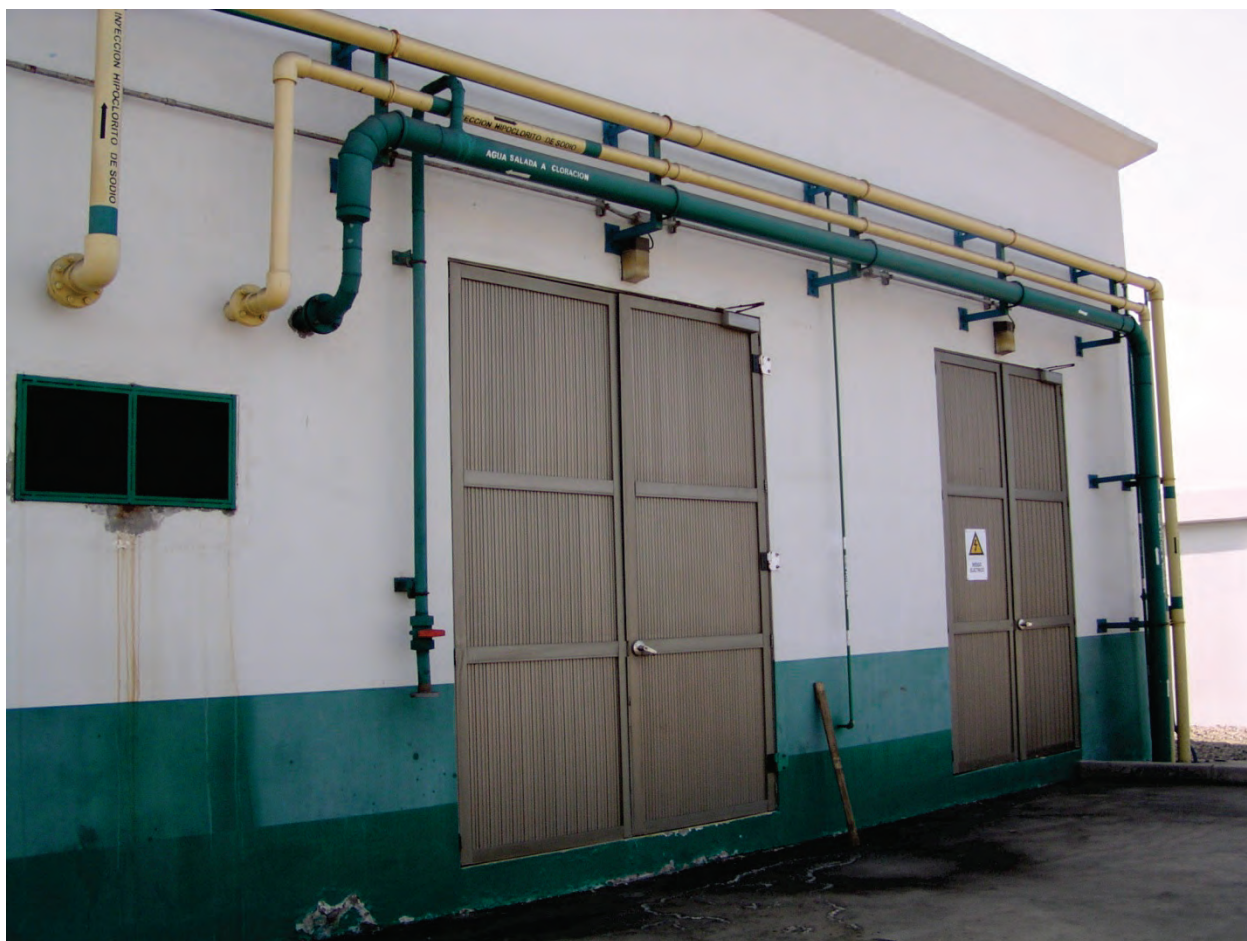
Figure 6.4.3.7-1 Wall-mounted supports for horizontal and vertical pipe runs with exterior exposure. Photo shows minor damage at wall penetration of green pipe and minor movement at some U-bolts, but restraints generally performed well (Photo courtesy of Eduardo Fierro, BFP Engineers). Note that lateral restraint near an elbow can be used to provide longitudinal restraint for a perpendicular pipe run.

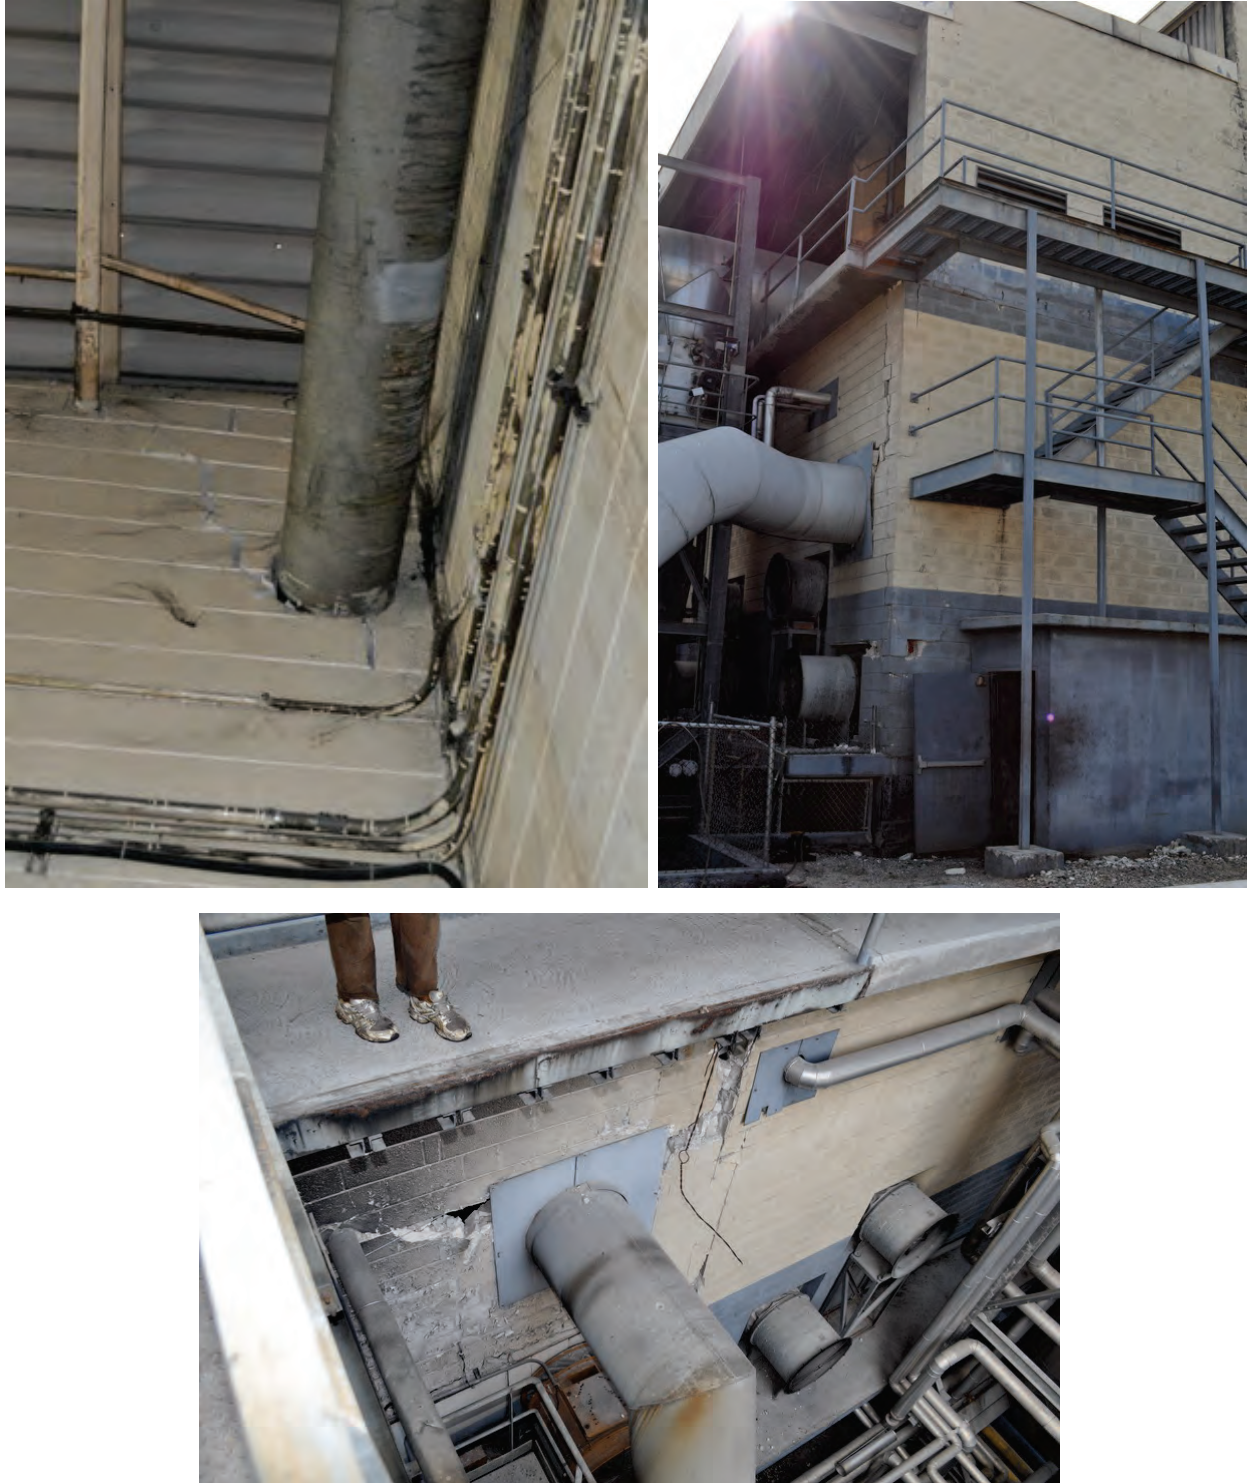
Figure 6.4.3.8-3 Wall penetrations for piping and ducts contributed to damage to unreinforced masonry walls at an industrial facility in the 2010 magnitude-7 Haiti Earthquake (Photos courtesy of Eduardo Fierro, BFP Engineers). The piping and ducts were not damaged but the walls cracked and will need to be repaired.

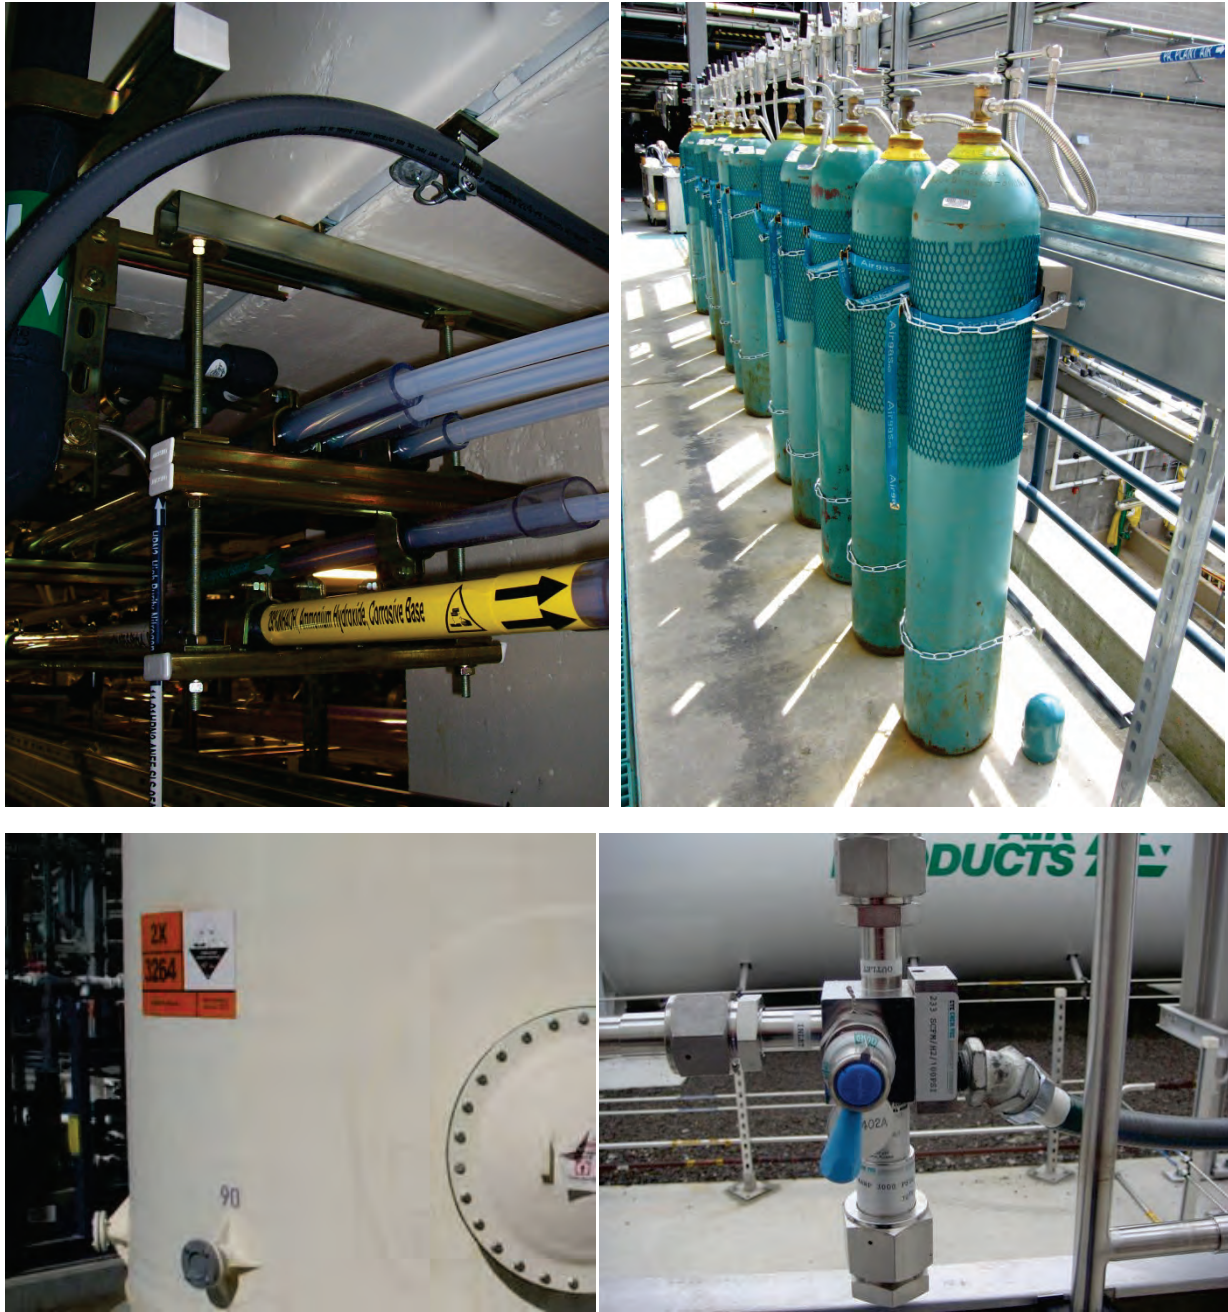
Figure 6.4.5.1-6 Clockwise from top: a) Sleeved pipe connections where seismic anchorage consists of cushioned pipe clamp attached around outer sleeve and inner pipe not restrained longitudinally. b) Airgas canisters chained and strapped to supports, fitted with flexible hose, stainless steel piping (note blue label), and a row of valves. c) Label on tank shows example of European ADR danger labeling scheme. d) Excess flow valve for large gas tank (Photos courtesy of Jeffrey Soulages, Intel Corporation).

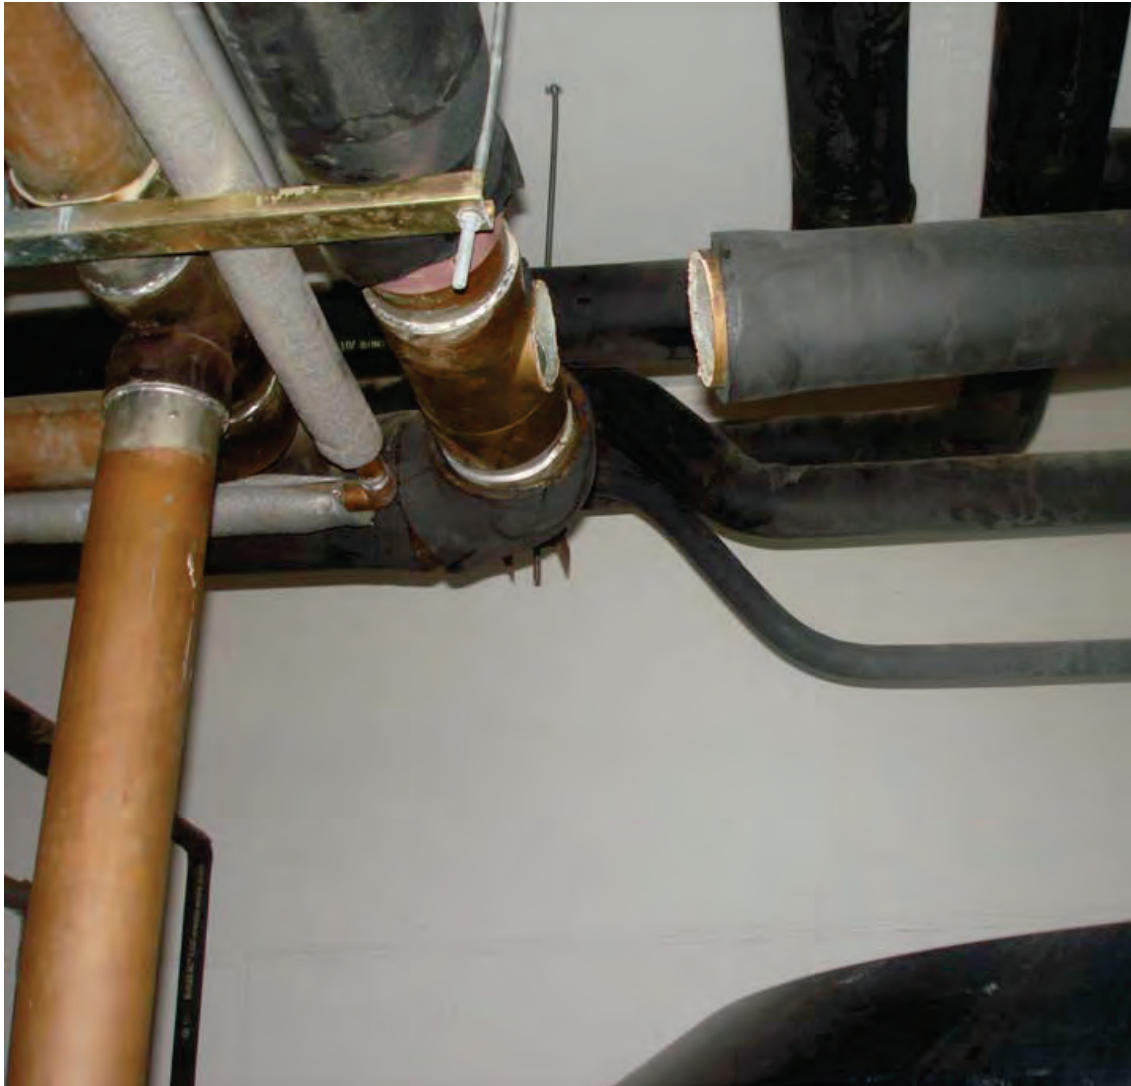
Figure 6.4.5.2-2 Broken copper piping for hot water supply in residential building in the 2010 Chile Earthquake. Trapeze shown not laterally braced but hangers appear to be less than 12" in length and may not have required lateral restraints per ASCE 7-10 (Photo courtesy of Gokhan Pekcan).

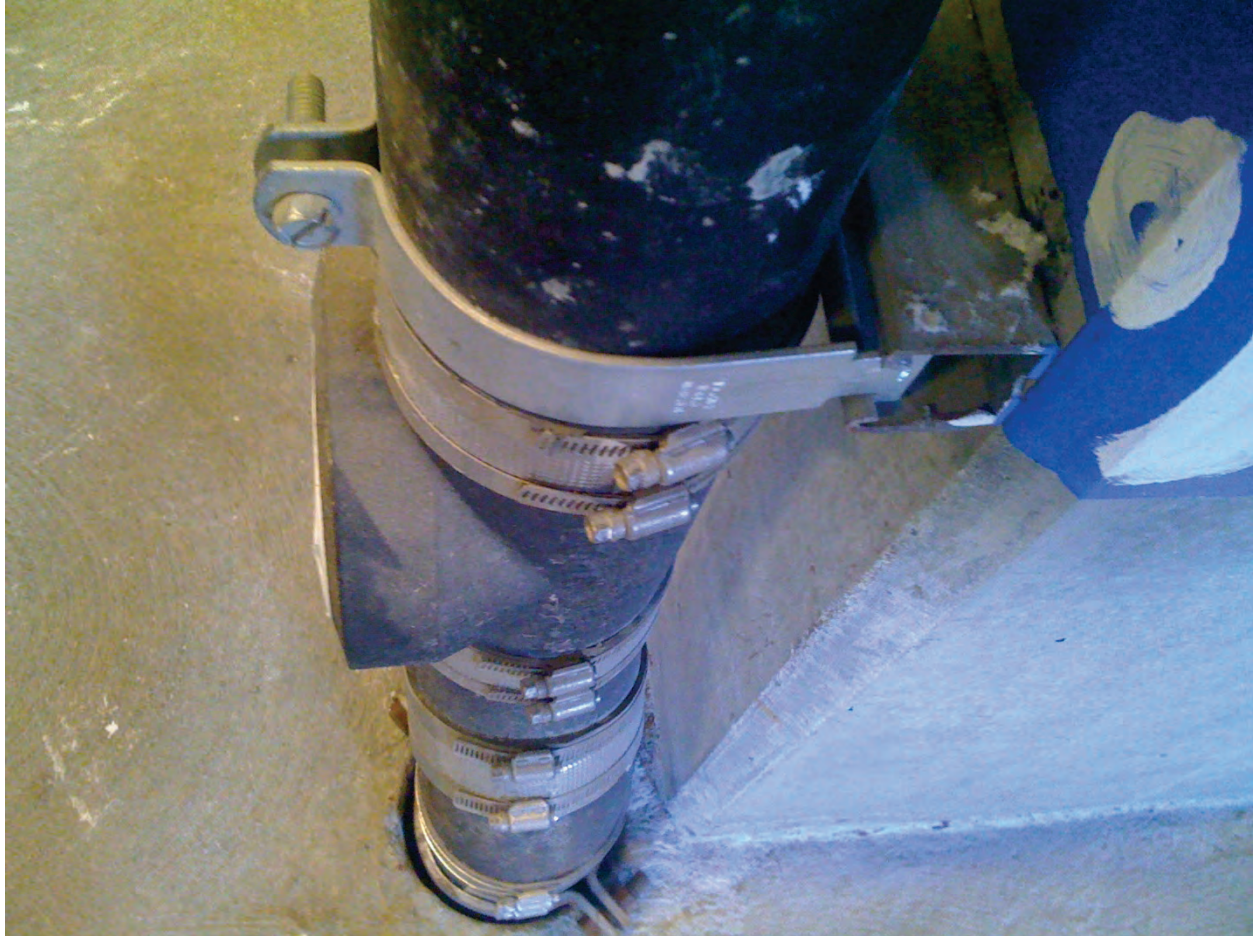
Figure 6.4.5.2-5 Poor example of sanitary sewer pipe support installed in San Francisco Bay Area in 2010; strut clamp has inadequate edge distance to end of strut and could slip off the end (Photo courtesy of Cynthia Perry, BFP Engineers).

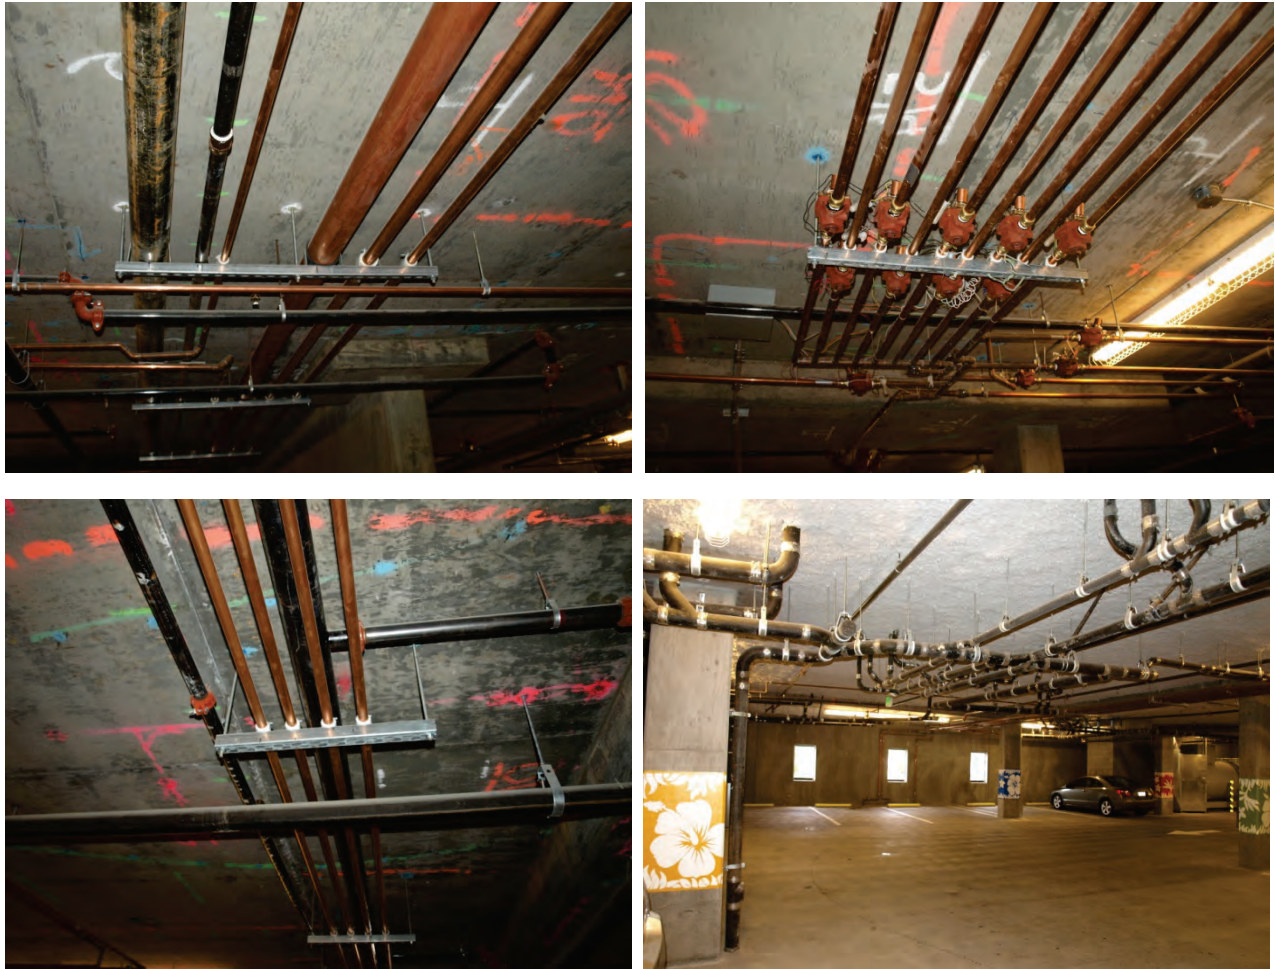
Figure 6.4.5.2-6 Piping installation in garage of mixed commercial/residential building San Francisco Bay Area completed in 2010. Note piping and trapeze supports do not have lateral restraints as all hangers were kept under 12" in length; only the sprinkler lines were laterally restrained. (Photo courtesy of Cynthia Perry, BFP Engineers).

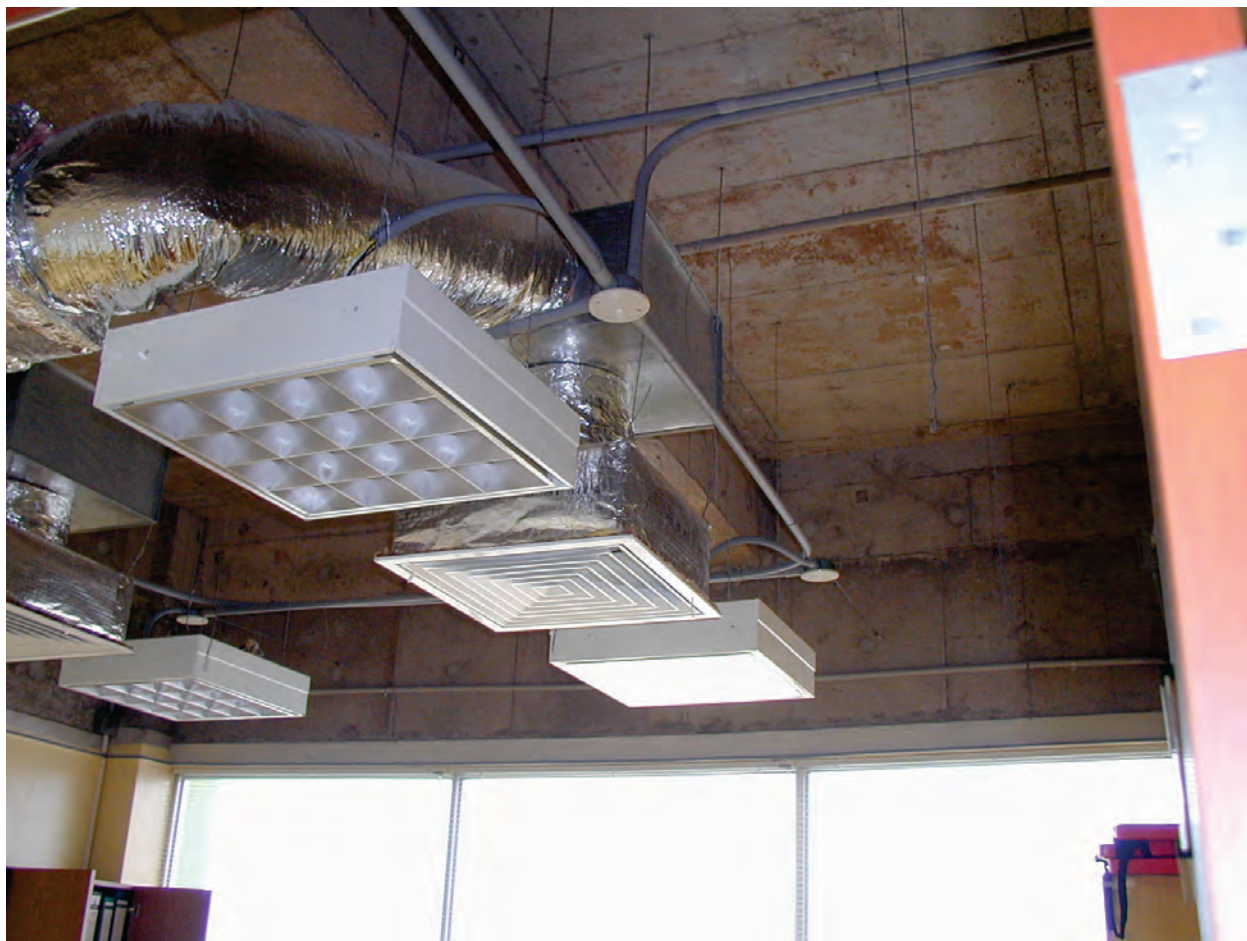
Figure 6.4.6.2-2 HVAC diffuser attached to the structure with four vertical hangers; ceiling system was damaged beyond repair in the 2001 Peru Earthquake but none of the diffusers or lights fell. Ceiling was demolished prior to photo (Photo courtesy of Eduardo Fierro, BFP Engineers).

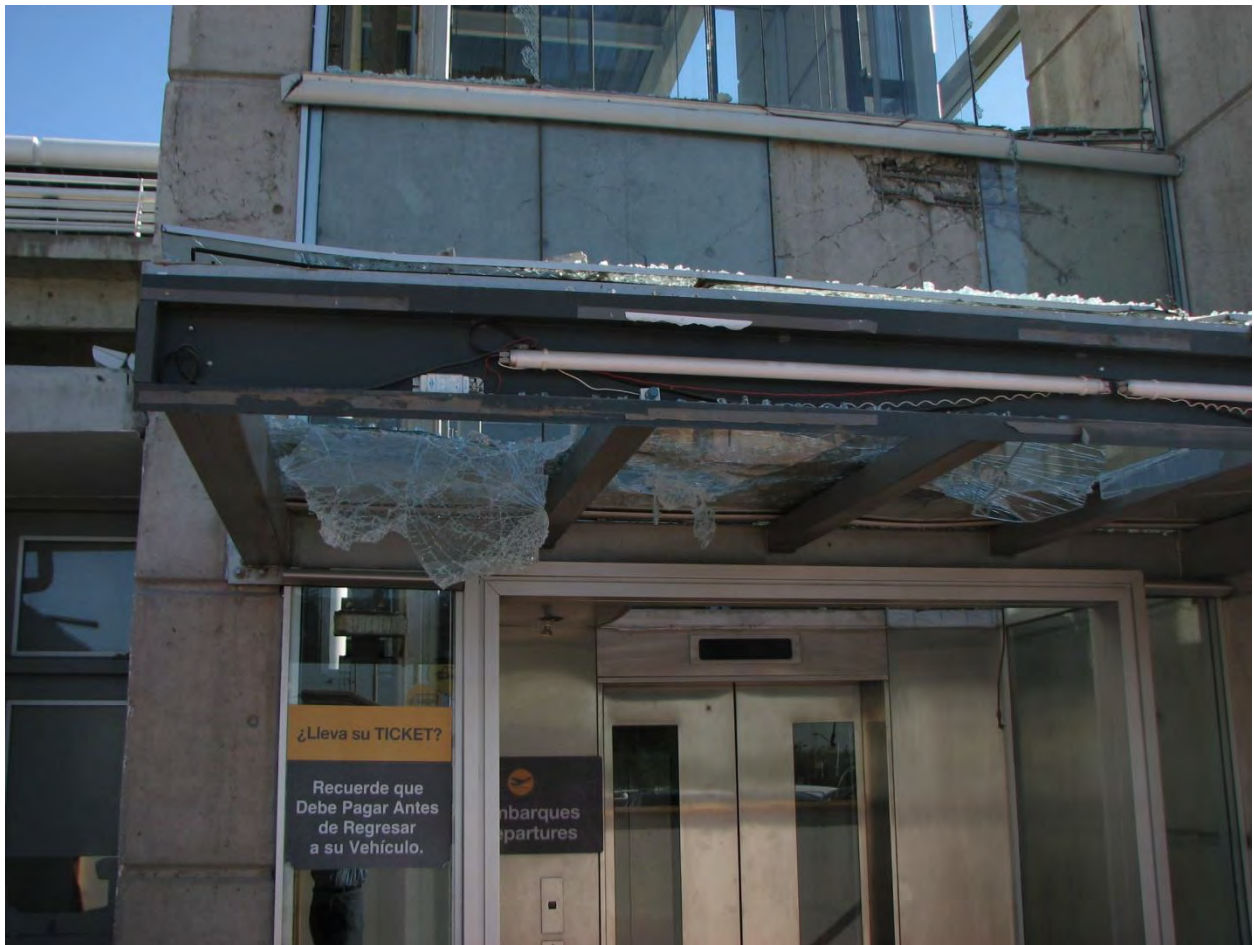
Figure 6.4.10.2-10 Glazing failures caused additional hazards at Santiago airport elevator in the 2010 Chile Earthquake (Photo courtesy of Antonio Iruretagoyena, Rubén Borsochek & Associates).

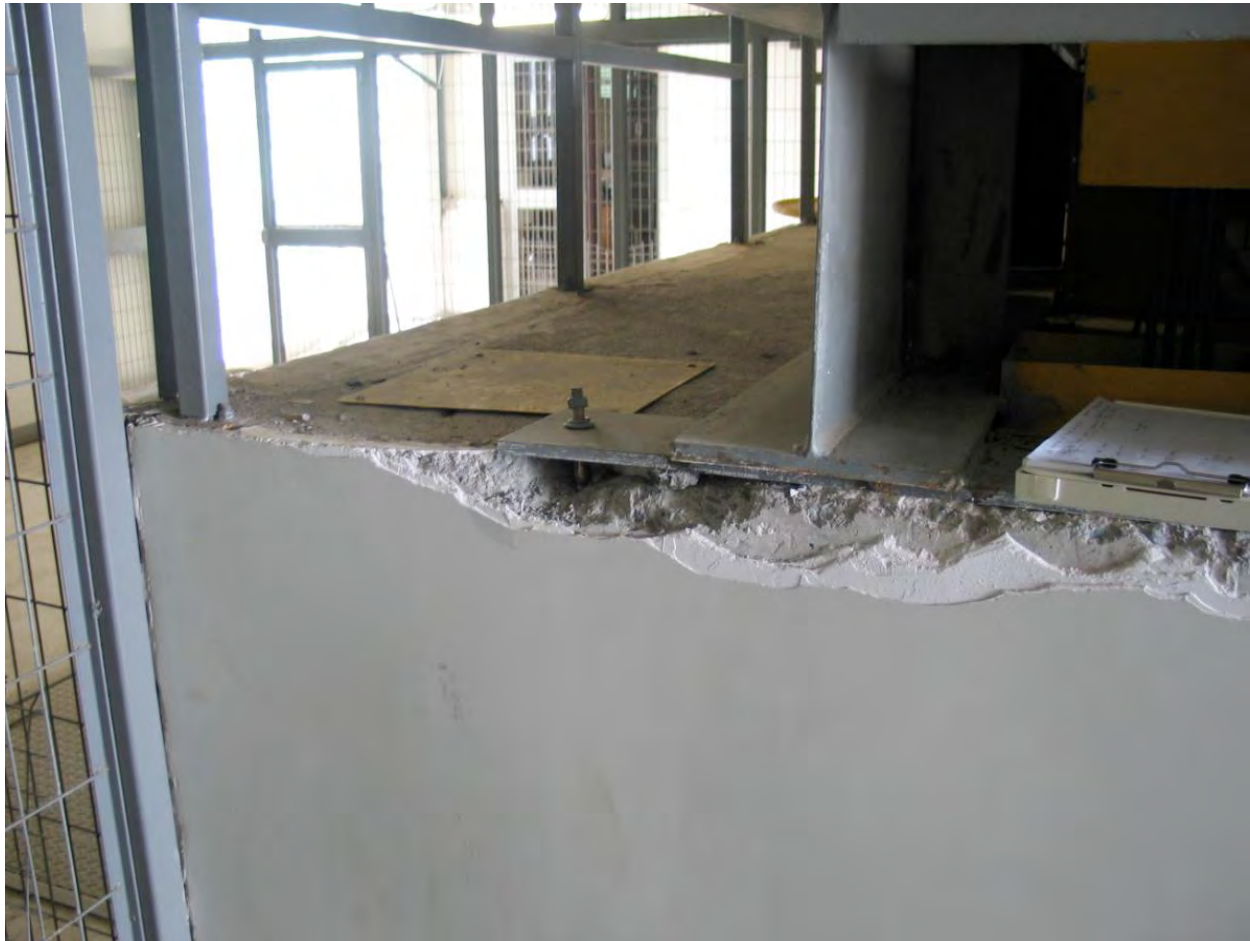
Figure 6.4.10.2-12 Anchor bolt failure of the elevator generator set due to inadequate edge distance for the bolts at the Los Angeles Regional Public Hospital in the 2010 Chile Earthquake (Photo courtesy of Bill Holmes, Rutherford & Chekene).
